Facility Review and Assessment
Town of North Andover, MA

Atkinson Elementary School

Date: 12.31.12

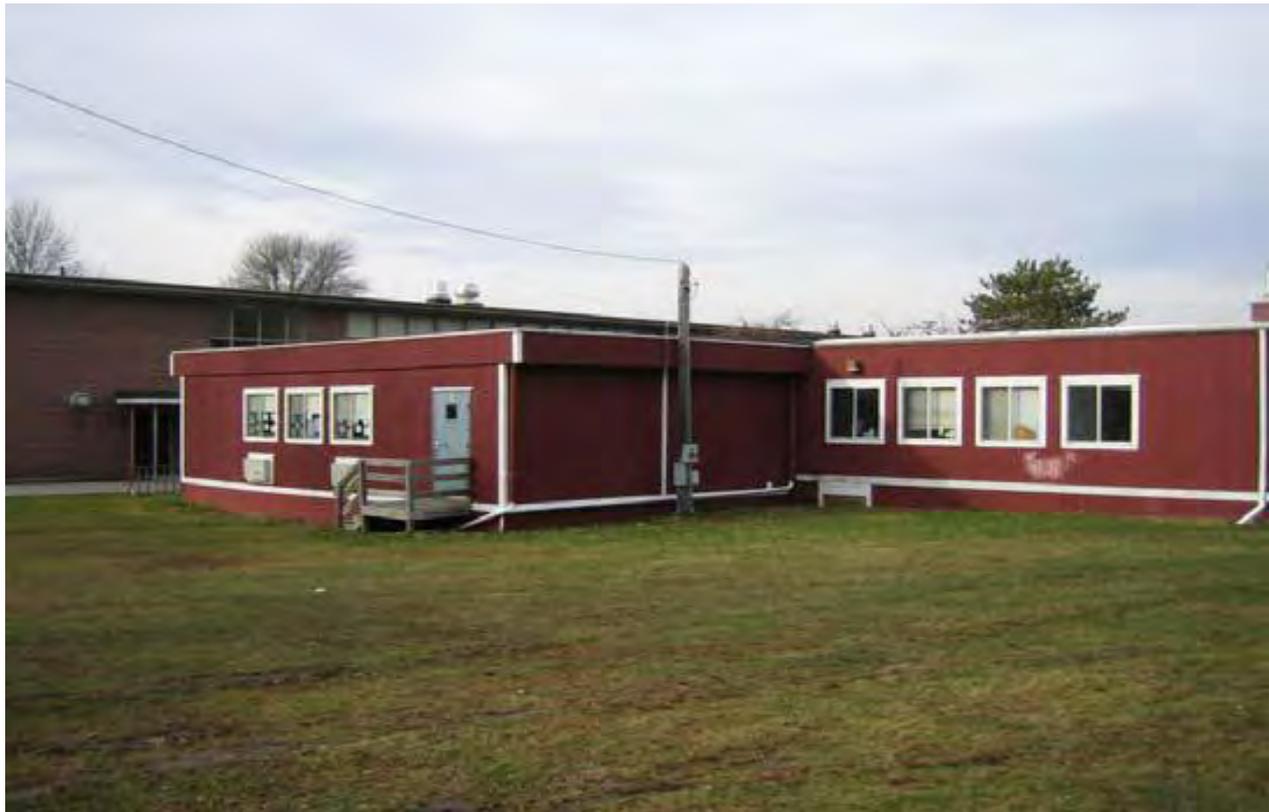
Portable temporary classrooms

- portable classroom - frequent monitoring/inspection of;
 - wood framed structure
 - masonry support piers
 - horizontal movement
 - water/moisture damage
- repair exposed 'spalled' concrete structural components

- Water intrusion mitigation measures;
 - portable classroom 'connector'
 - crawl space
 - Masonry repointing
- Portable classroom structures;
 - repair/replacement/sealing wood clad portable cladding
 - perimeter crawlspace & under-floor enclosure/insulation
 - window & doors
- building air sealing

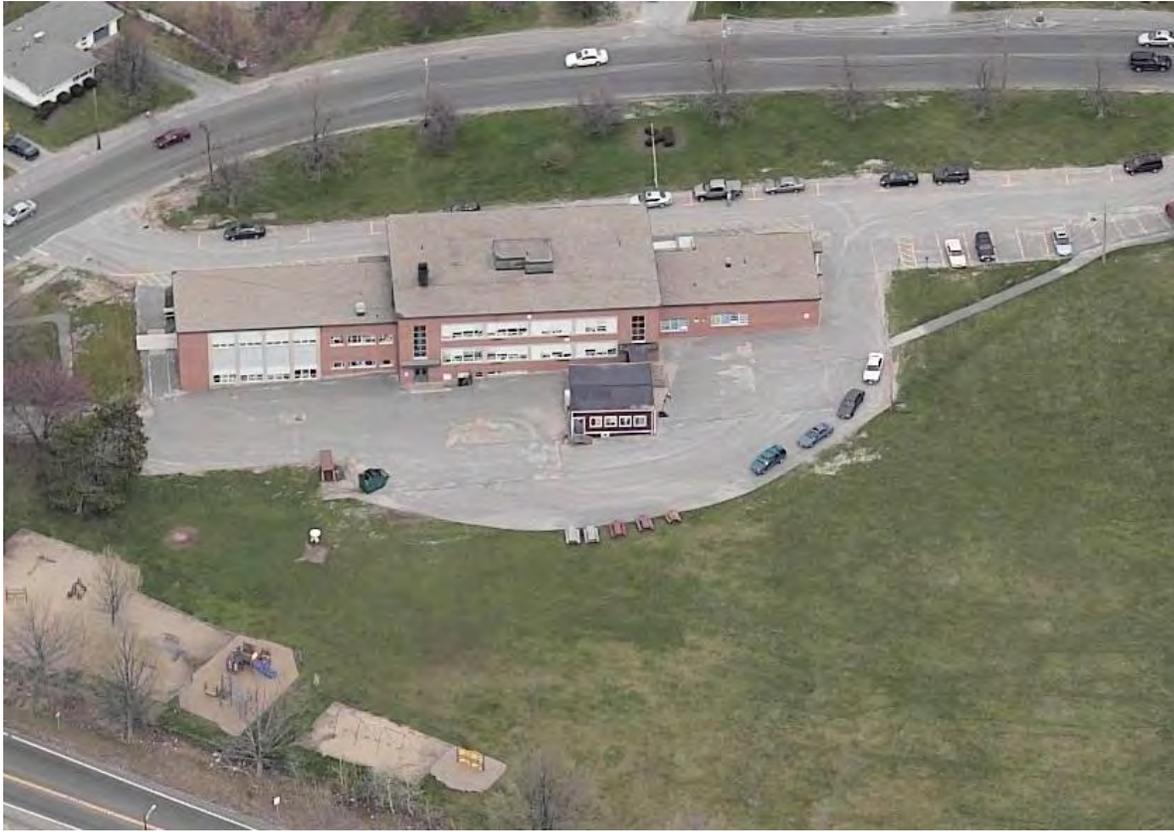
West elevation (old portable classroom since demolished-new modular at same location)
