**Facility Review and Assessment
Town of North Andover, MA**

Department of Public Works

384 Osgood Street
North Andover, MA

Date: 12.31.2012

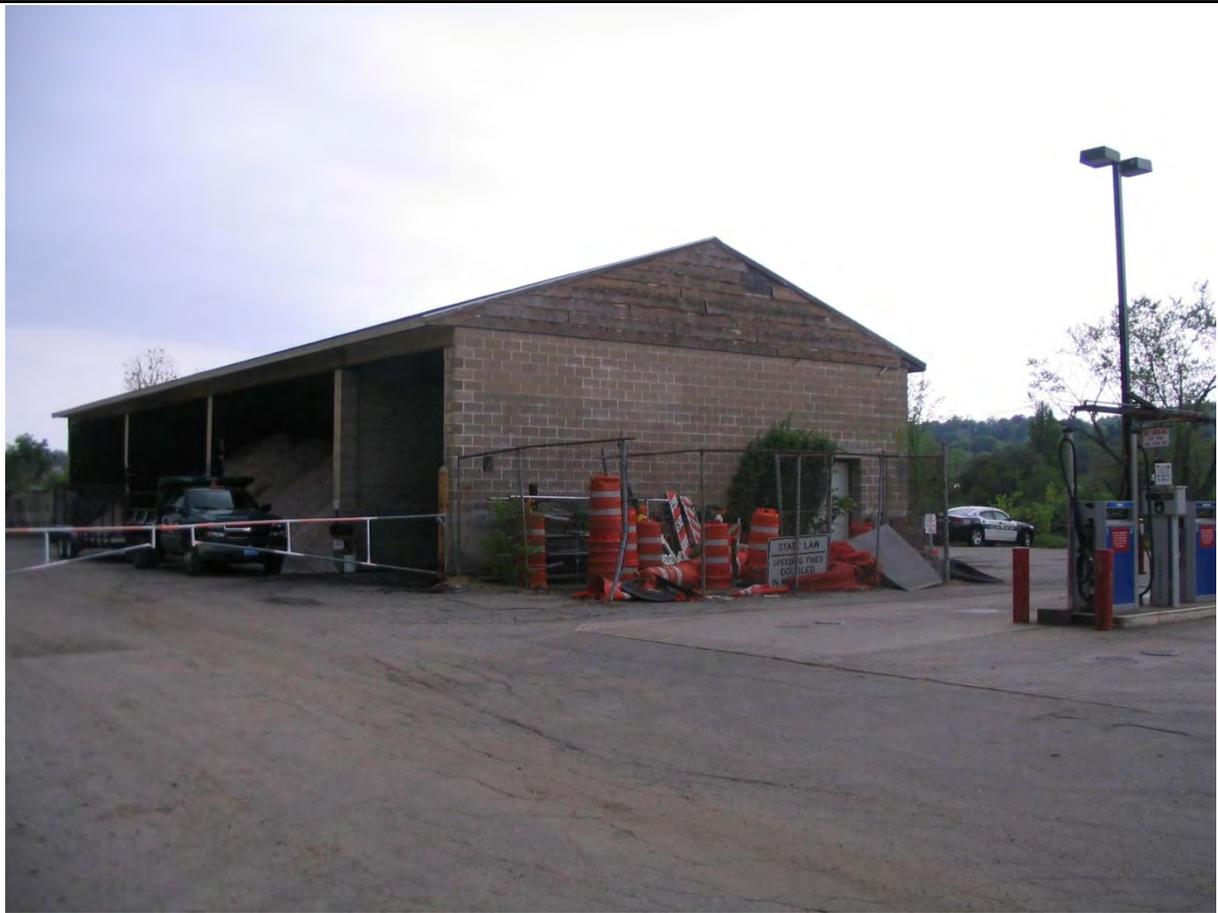
Salt shed & fueling island
