# Town-wide Playground Assessments

Town of North Andover, Massachusetts

February 12, 2015

**Christine Scypinski, LEED AP  
Registered Landscape Architect**

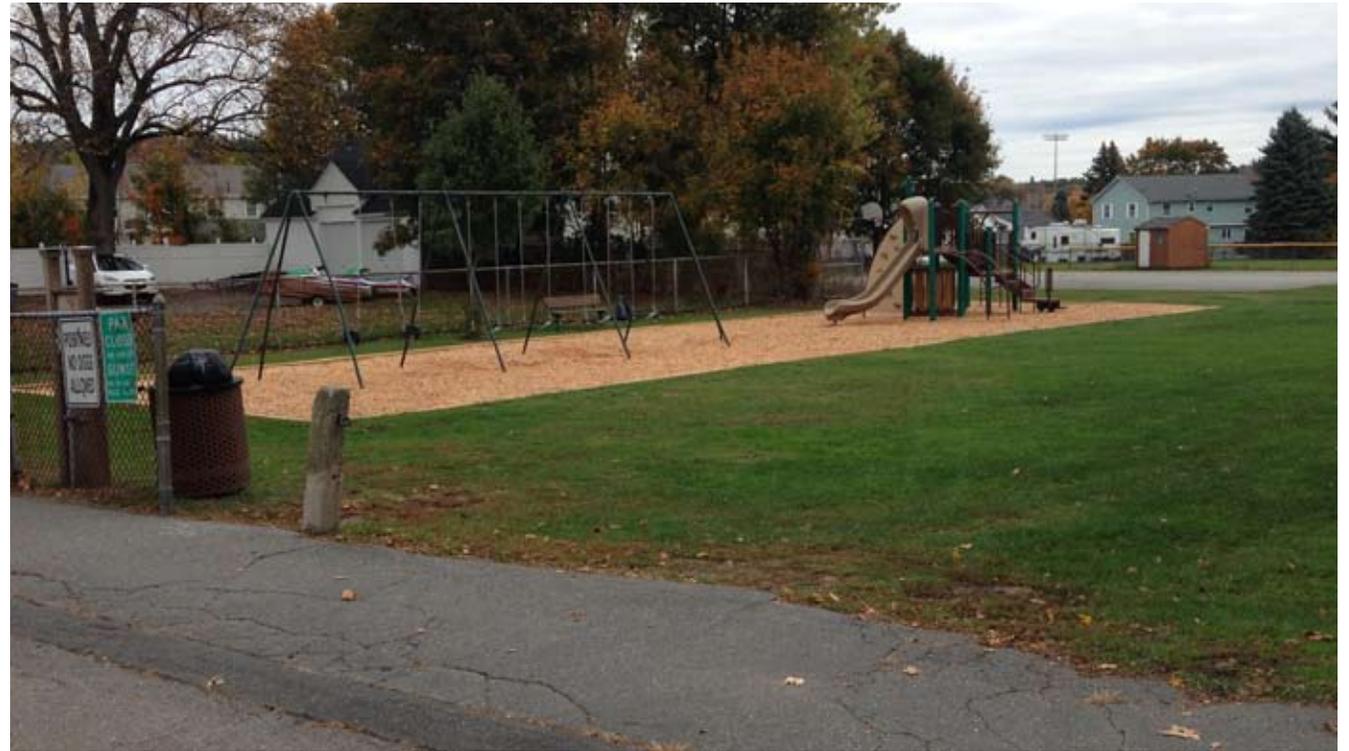
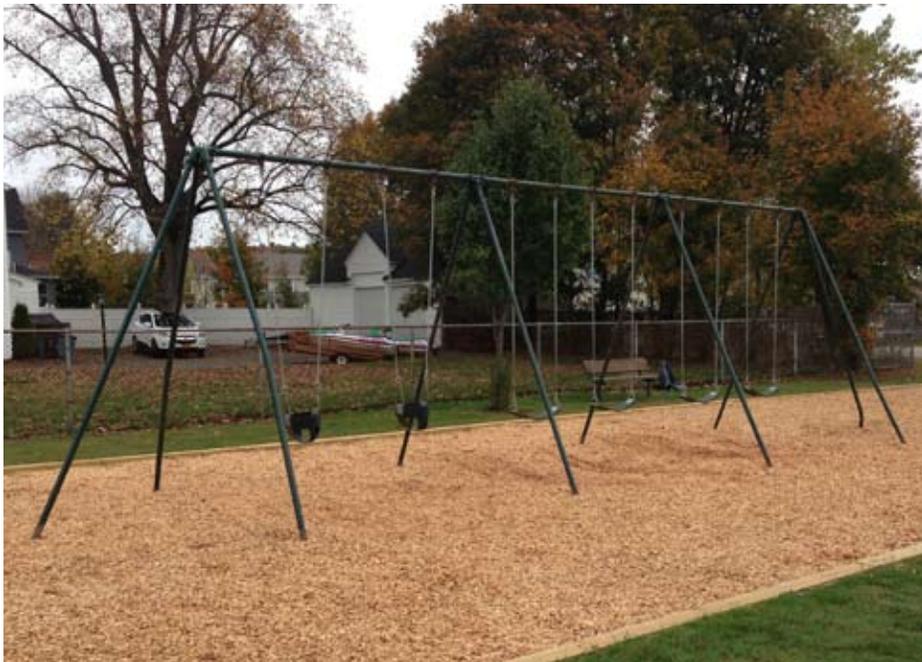
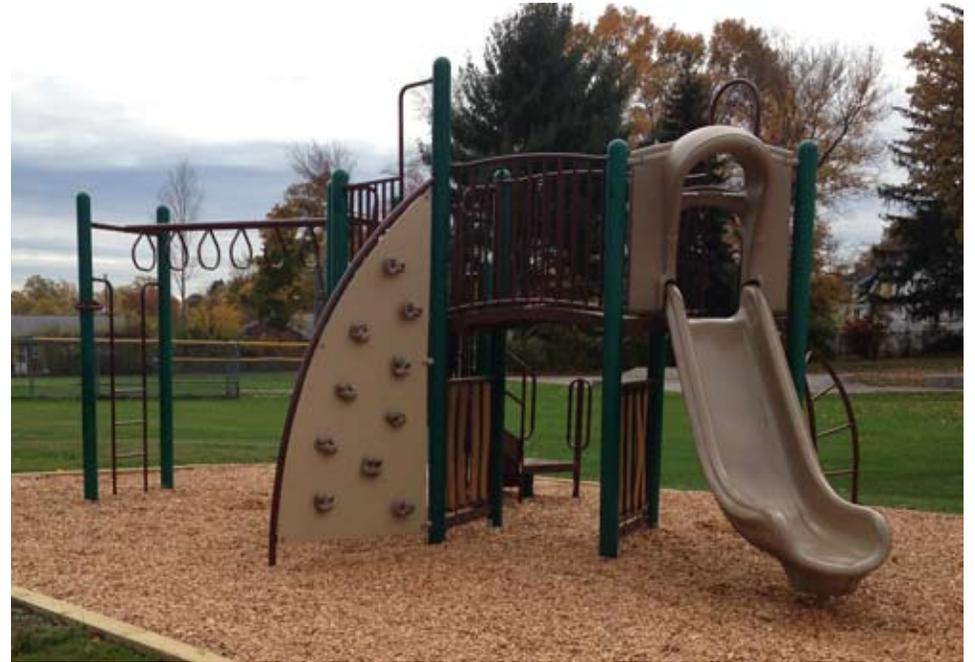
Item	Ranking	Comments
Play Equipment Safety	1	good
Play Equipment Condition	3	fair - minor maintenance issues; extensive rust and peeling paint on swing posts; bent swing post
Play Equipment Universal Accessibility	1	good
Play Diversity and Separation for age groups and activities	3	fair for young children; separation of swings
Access to Playgrounds (accessible route)	5	no accessible path - flat grass to wood tie edge
Play Surface Accessibility	5	appears to be wood chips which is not acceptable; additional non-compliance evident in displaced wood chip areas at swings
Play Surface Condition & Safety (extent, depth, drainage)	5	wood chip surface is not as safe as wood fiber - 12"+ depth in general; deficient depth and deep ruts at swings and slides; deficient use zone around swings (need 2x ht)
Surfacing Edge Condition & Safety	1	new wood edge in good condition- could be CCA treated
General Playground Maintenance, Safety & Comfort	3	no trash or graffiti although maintenance issues noted for surface, no sun protection on south sides, no age appropriate signage, bench with small shade tree

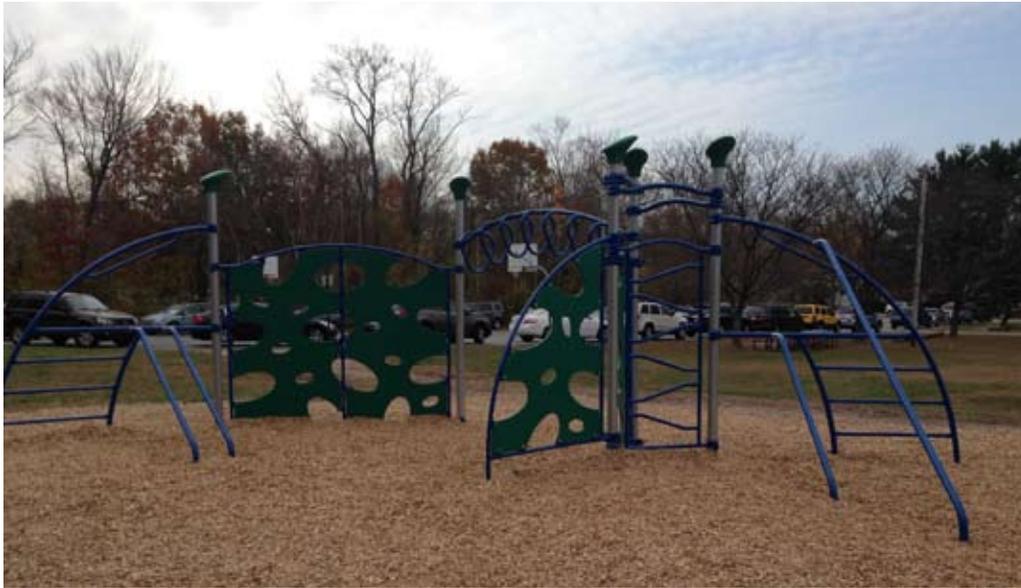
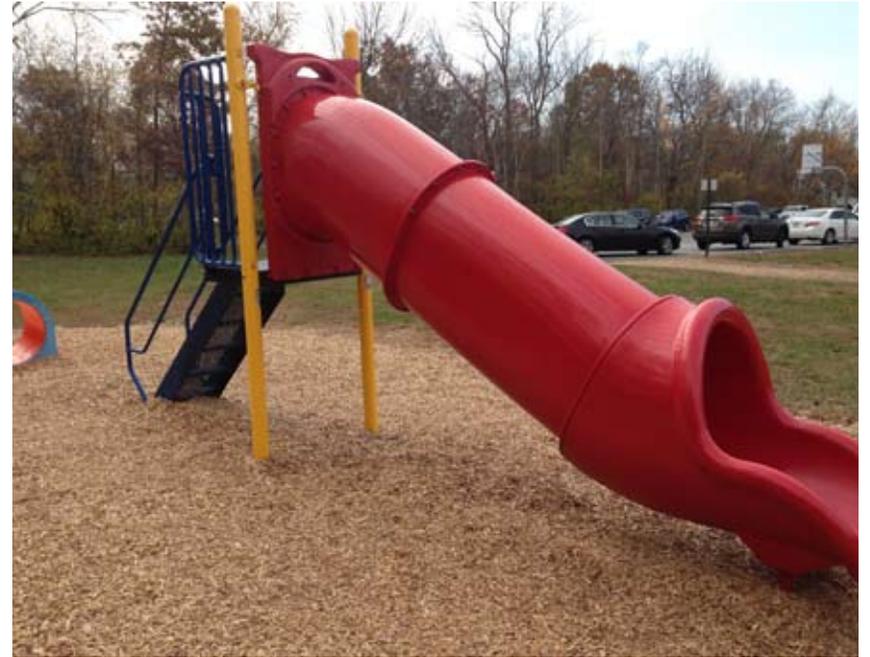
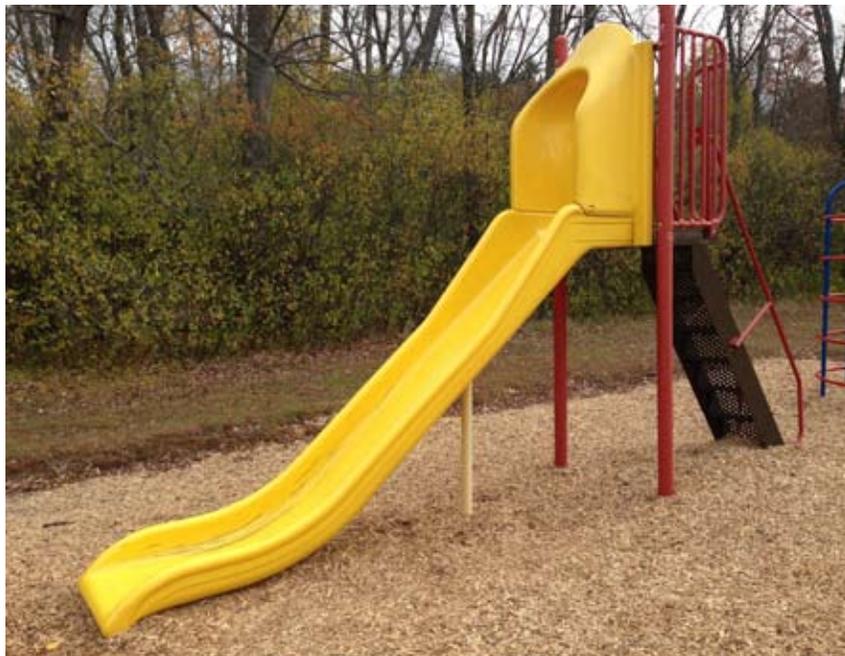
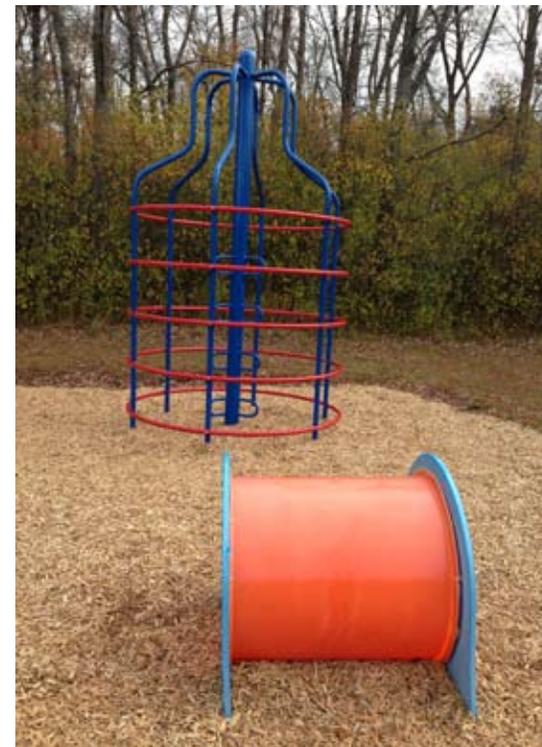
Item	Ranking	Comments
Play Equipment Safety	2	minor maintenance issues; considerable bare metal on dome and swing chains in full sun; potential bolt projection hazard on slide platform
Play Equipment Condition	2	new age 5-12 and 2-5 climbers - excellent; 6 bays of belt swings, climbing dome, stand-alone slides (2), climber & tunnel are older but strong - needs paint, missing bolts, bent rungs
Play Equipment Universal Accessibility	1	good for newer equipment
Play Diversity and Separation for age groups and activities	2	challenging; great play value; separation by age but lacks buffer areas
Access to Playgrounds (accessible route)	4	no accessible path to new 5-12 climber; poor mulch/dirt path to other pieces from parking lot - flat
Play Surface Accessibility	4	appears to be engineered wood fiber surface which can be accessible when maintained correctly (raked, filled, compacted in layers); non-compliance evident in displaced fiber areas; compaction of fiber topping needed; wood chips can not be substituted

Play Surface Condition & Safety (extent, depth, drainage)	4	wood fiber surface 12"+ depth in general; deficient depth under dome climber (7" to sand) and deep ruts at swings and slides; deficient use zone around swings (need 2x ht) and slides > 6' ht
Surfacing Edge Condition & Safety	5	no edge; wood fiber surface migrating
General Playground Maintenance, Safety & Comfort	4	no trash or graffiti although maintenance issues noted for equipment and surface, no barrier between parking and age 2-5 equipment but some distance, no sun protection on south sides, missing age appropriate signage, no benches or shade

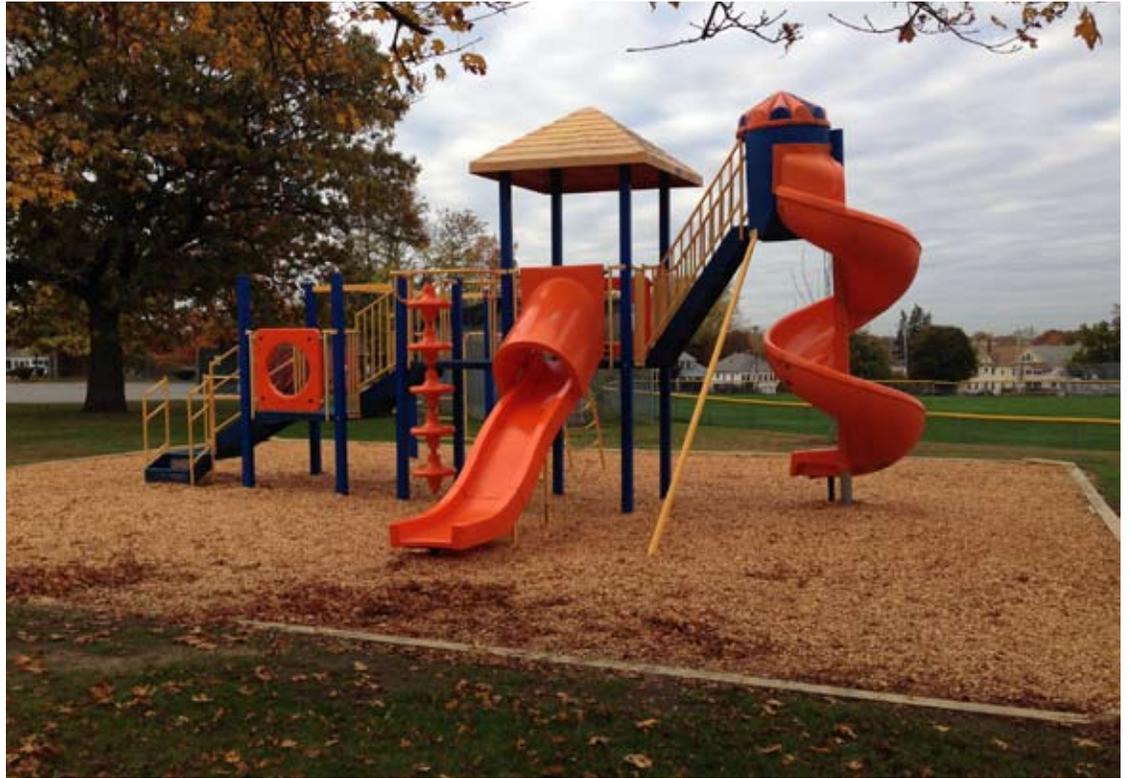
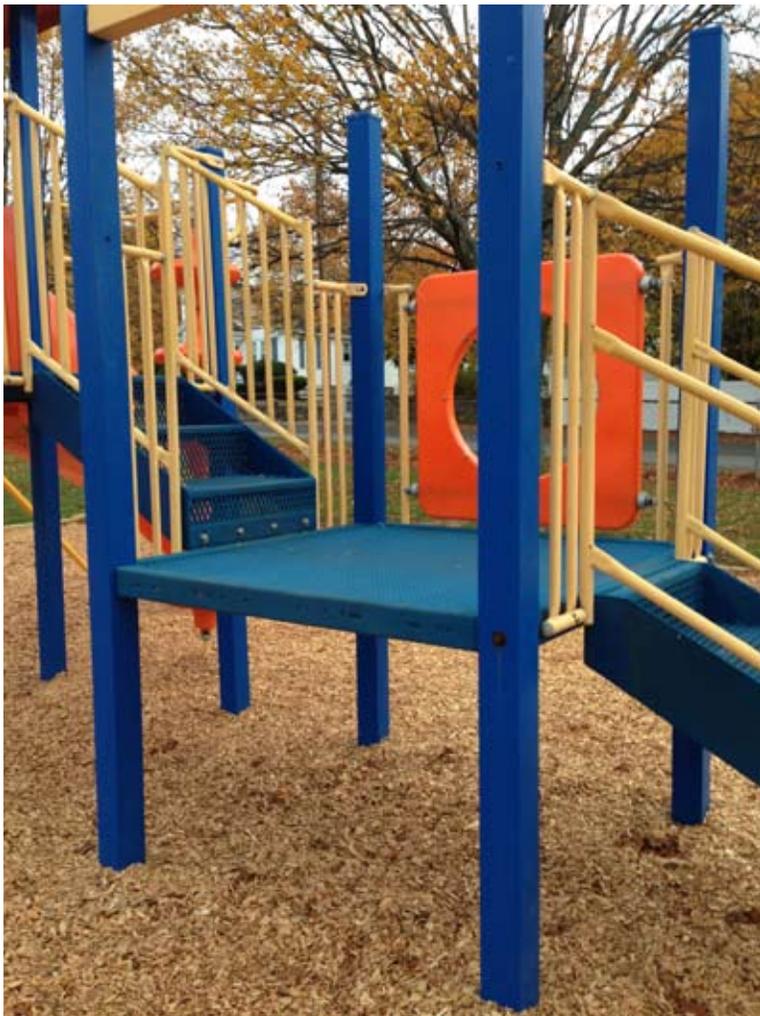
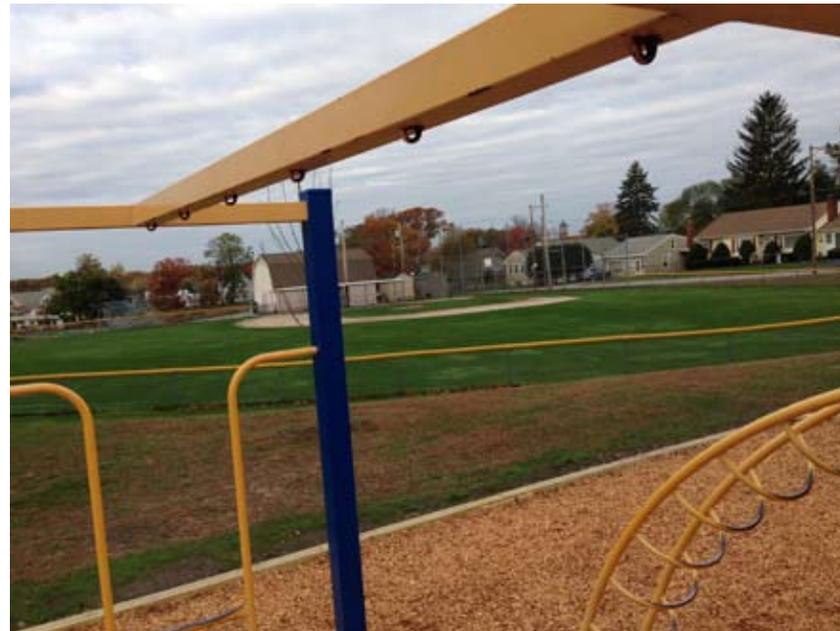
Item	Ranking	Comments
Play Equipment Safety	5	poor - old climber lacking barriers and guard rails; non-compliance with safety guidelines
Play Equipment Condition	5	poor - maintenance issues; extensive rust; bare metal in full sun; graffiti on plastic pieces; missing parts - overhead rungs
Play Equipment Universal Accessibility	5	poor
Play Diversity and Separation for age groups and activities	5	poor- no ground level activities or swings (swings shown on aerial photo have been removed)
Access to Playgrounds (accessible route)	5	no accessible path - flat grass to wood tie edge
Play Surface Accessibility	5	appears to be wood chips which is not acceptable; additional non-compliance evident in displaced wood chip areas at slides
Play Surface Condition & Safety (extent, depth, drainage)	4	wood chip surface is not as safe as wood fiber - 12"+ depth in general; deficient depth and deep ruts at slides
Surfacing Edge Condition & Safety	1	new wood edge in good condition- could be CCA treated

General Playground Maintenance, Safety & Comfort	3	no trash, graffiti on play equipment, maintenance issues noted for surface, no age appropriate signage, no benches, shade canopies and small trees

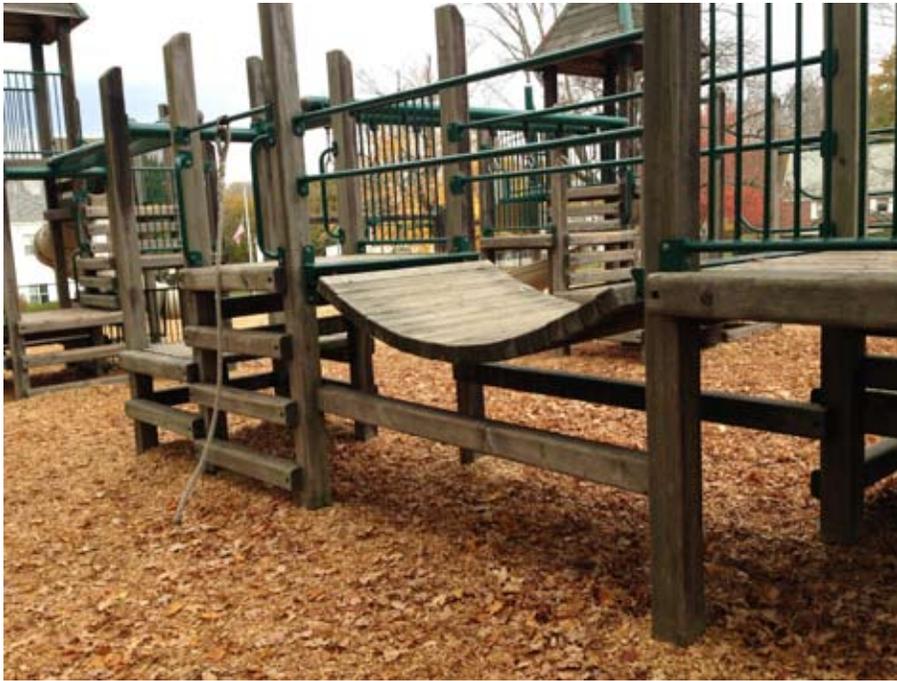
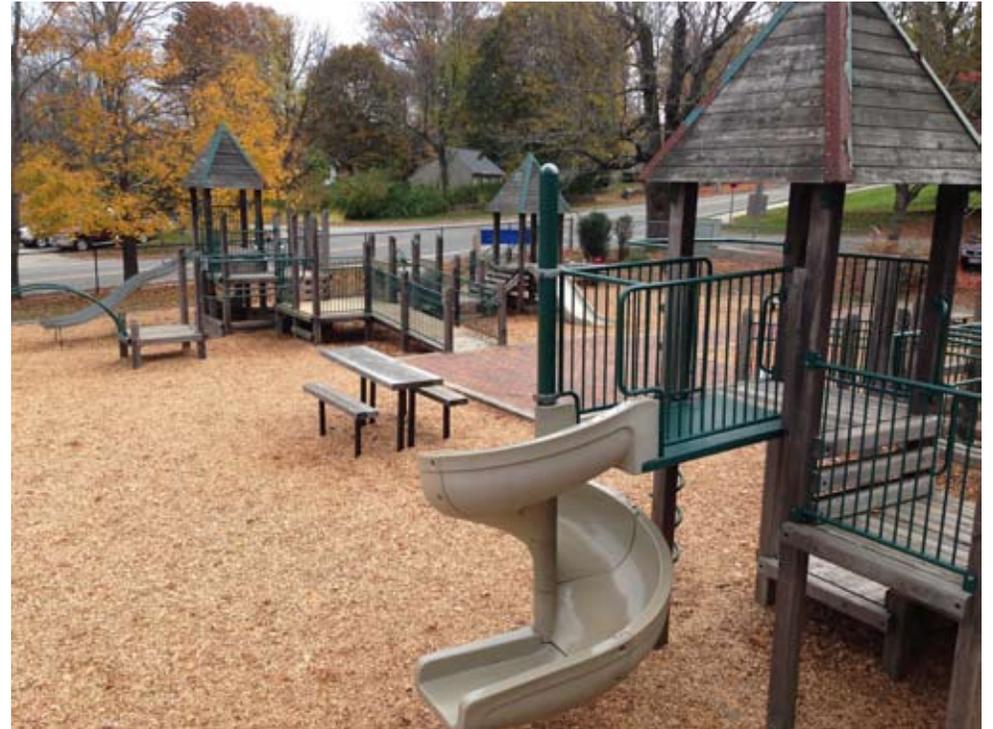
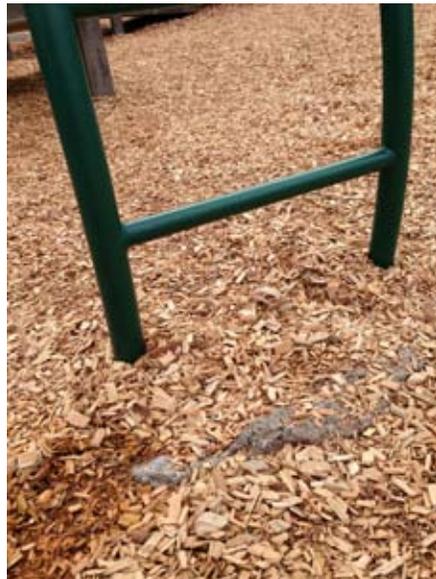
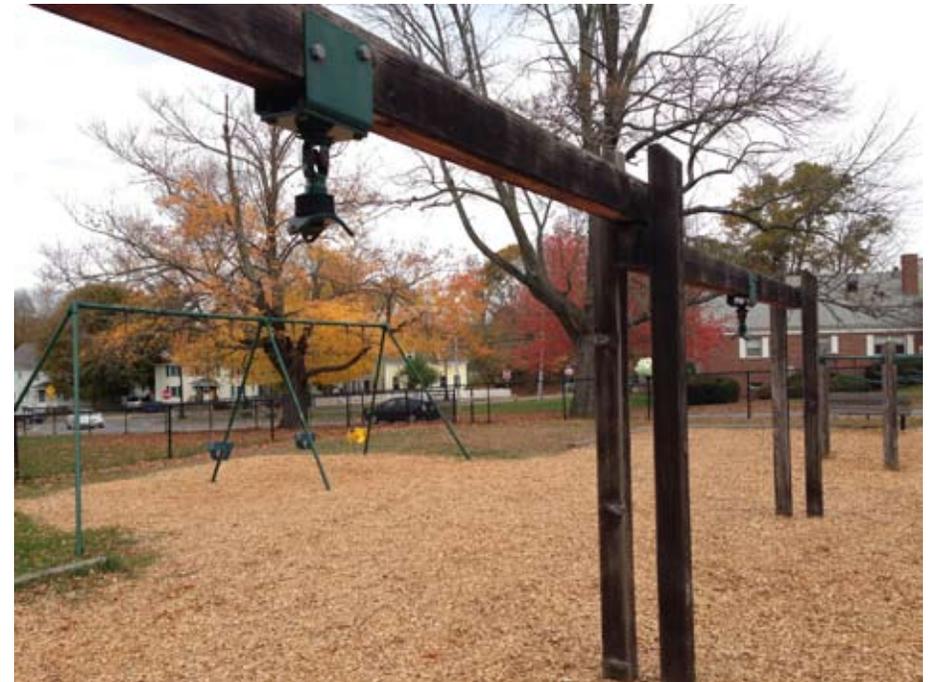
Item	Ranking	Comments
Play Equipment Safety	5	poor-multitude of safety issues including: unstable / unbolted spring platform and slide end; finger pinch hazards; loose and missing parts; unstable/rocking slides; open and rusty S hooks and chains; frayed climbing ropes; rusty metal and peeled paint; exposed concrete footings causing trip hazards
Play Equipment Condition	5	old (1991-1993) wood equipment in poor condition with many missing and deteriorated parts and hazards; rust on metal pieces; mildew and some deterioration on wood members especially decking; many areas under repair
Play Equipment Universal Accessibility	4	non-compliance due to age of structures - appears to be in repair with accessibility being improved
Play Diversity and Separation for age groups and activities	3	challenging; good play value; separation by age and activity; multitude of ground level activities; missing tire swings and toddler swings

Access to Playgrounds (accessible route)	3	accessible route to parking eroded to dirt surface
Play Surface Accessibility	5	appears to be wood chips which is not acceptable; additional non-compliance evident in displaced wood chip areas at slides and swings
Play Surface Condition & Safety (extent, depth, drainage)	5	wood chip surface is not as safe as wood fiber - 6" and less depth in general; deficient depth and deep ruts at slides and swings; exposed concrete footing; deficient use zone at swings; grass growing
Surfacing Edge Condition & Safety	1	old wood but in good shape - may be CCA treated
General Playground Maintenance, Safety & Comfort	2	no trash or graffiti although multitude of maintenance issues noted for equipment and surfacing; playground is under repair; separation from road and parking with fence and gate - under repair; shade from mature trees and canopies on equipment; missing age appropriate signage; wood benches in poor shape and picnic tables

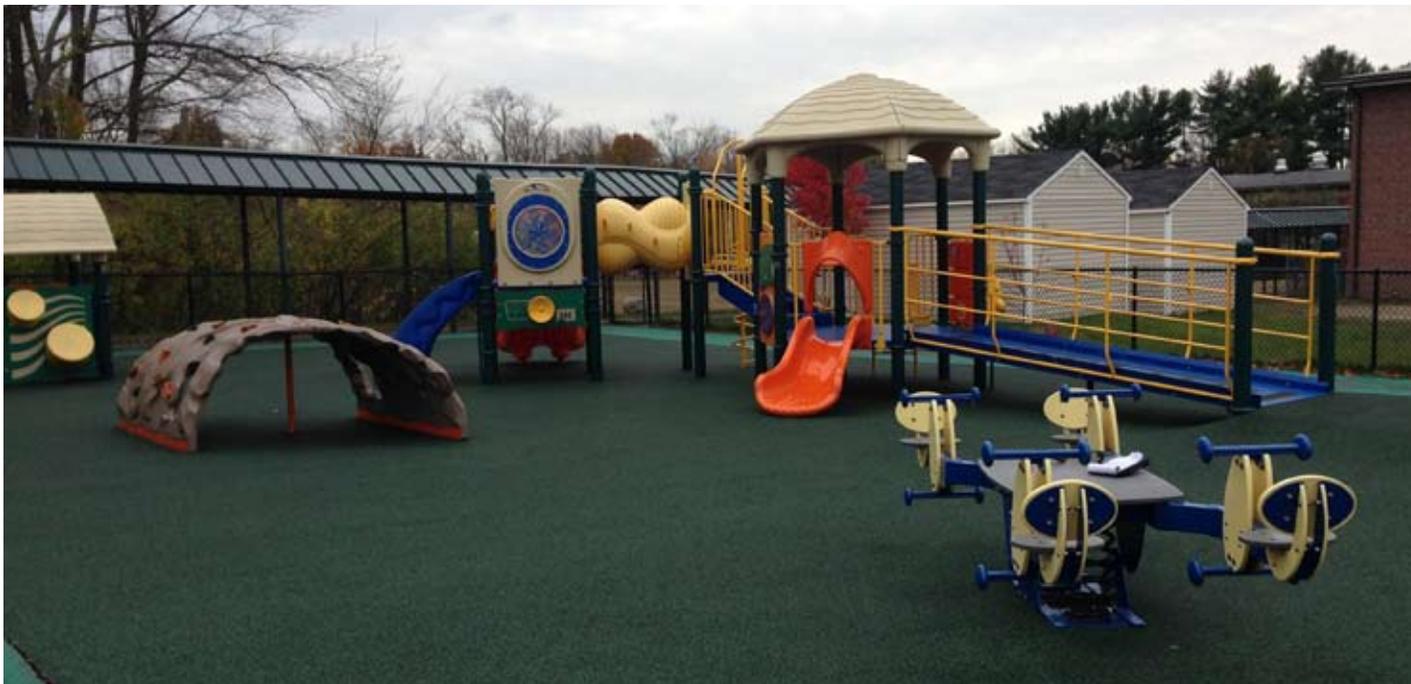
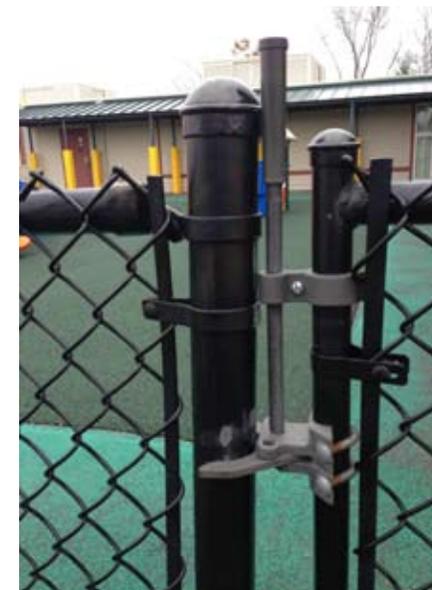
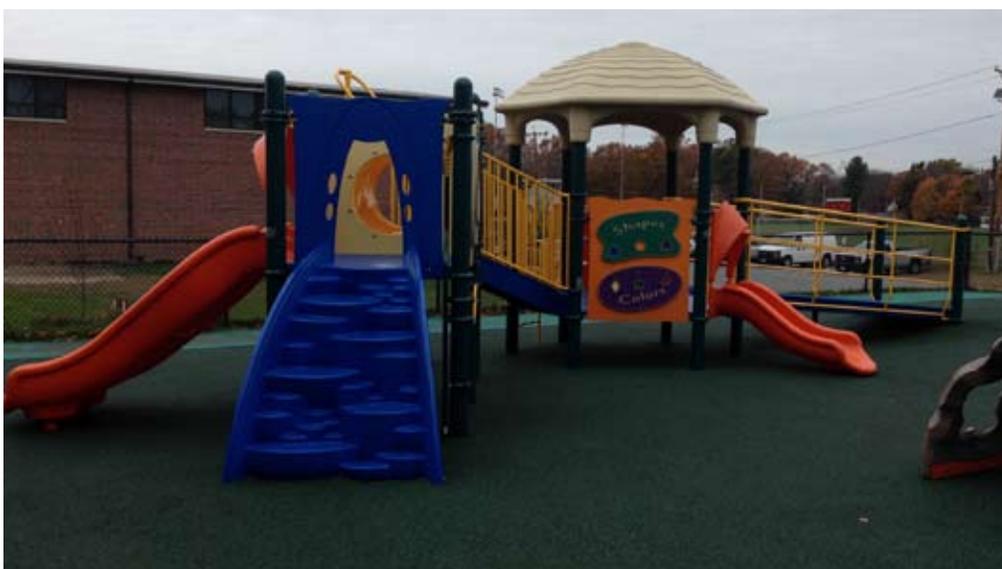
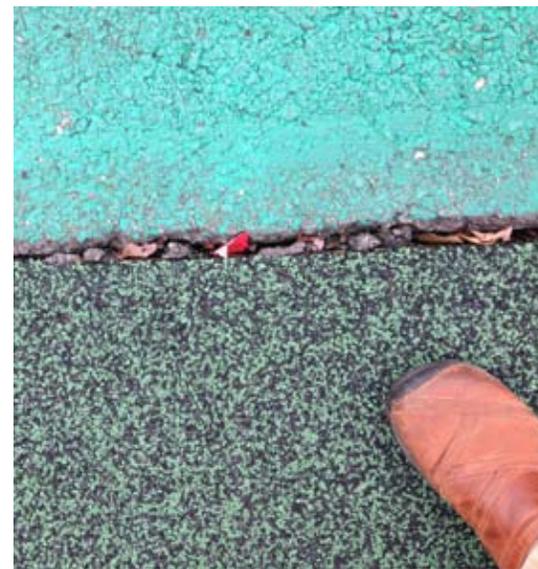
Item	Ranking	Comments
Play Equipment Safety	1	fairly new equipment in great shape (5 years old)
Play Equipment Condition	1	excellent: fairly new equipment; small areas of peeled paint/rust; bolt missing
Play Equipment Universal Accessibility	1	excellent
Play Diversity and separation for age groups and activities	1	challenging; great play value; separation by activity
Access to Playgrounds (accessible route)	2	fully accessible from buildings and parking to playground; > 1/2" gap at interface of bituminous path and rubber surface is non-compliant
Play Surface Accessibility	1	fully accessible between equipment
Play Surface Condition & Safety (extent, depth, drainage)	1	appears to be sufficient for equipment and age; a few areas where surface has separated from equipment forming 1/4" - 1/2" gaps
Surfacing Edge Condition & Safety	5	> 1/2" gap at interface of bituminous path and rubber surface; bituminous edge deteriorating

General Playground Maintenance, Safety & Comfort	2	well maintained, sun protection on equipment and small shade trees, picnic table, perimeter fence and secure gates, no conflicts with adjacent uses, missing age appropriate signage

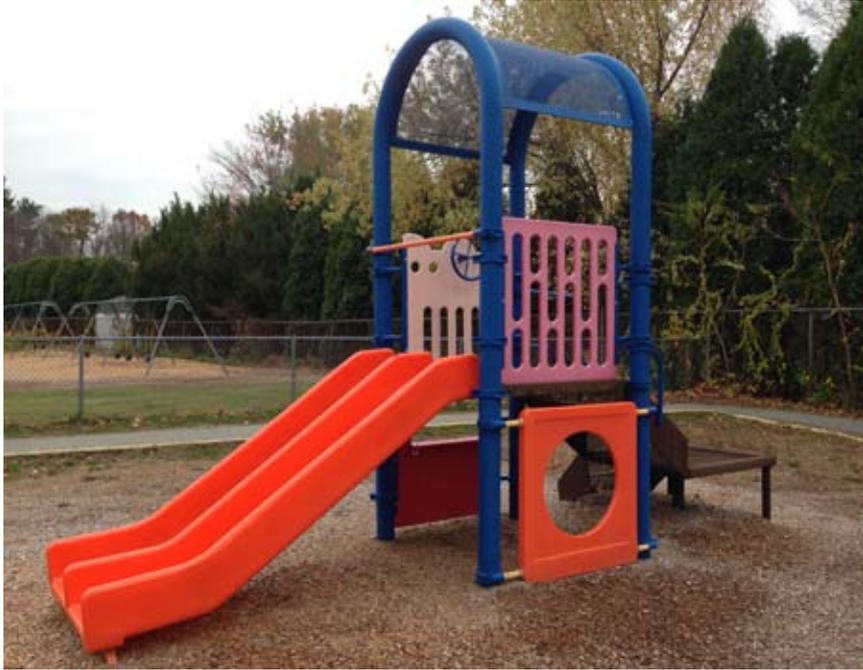
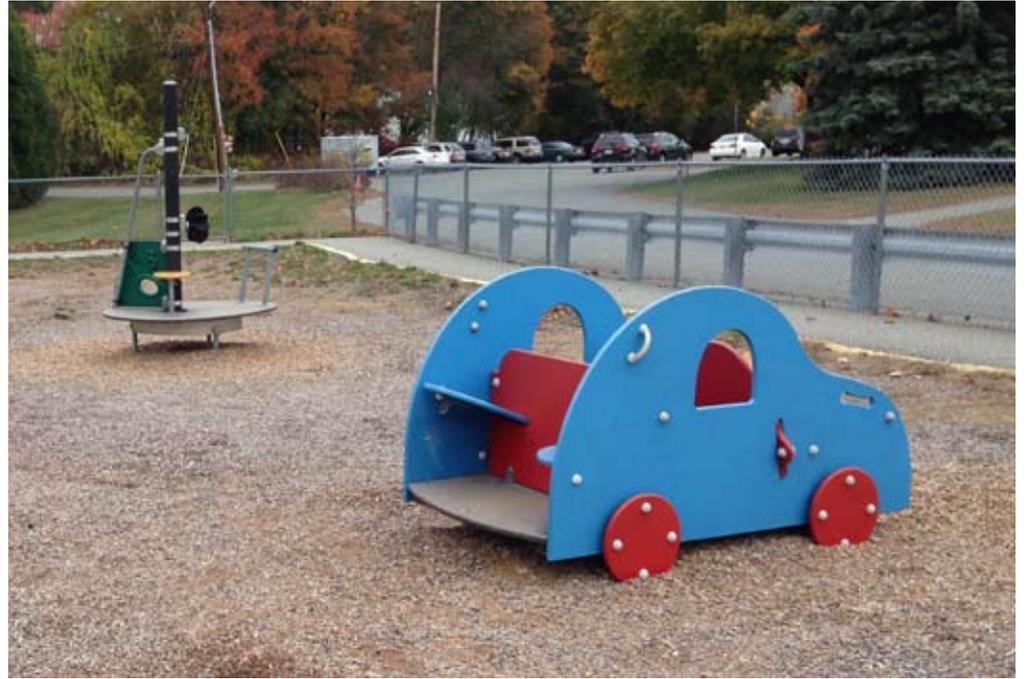
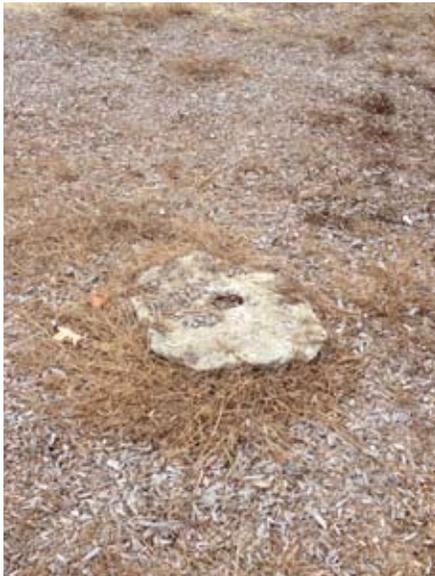
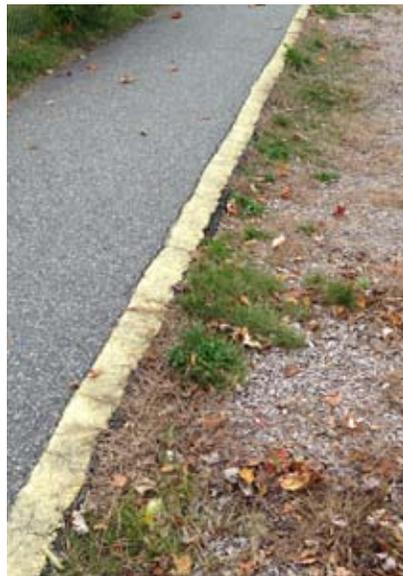
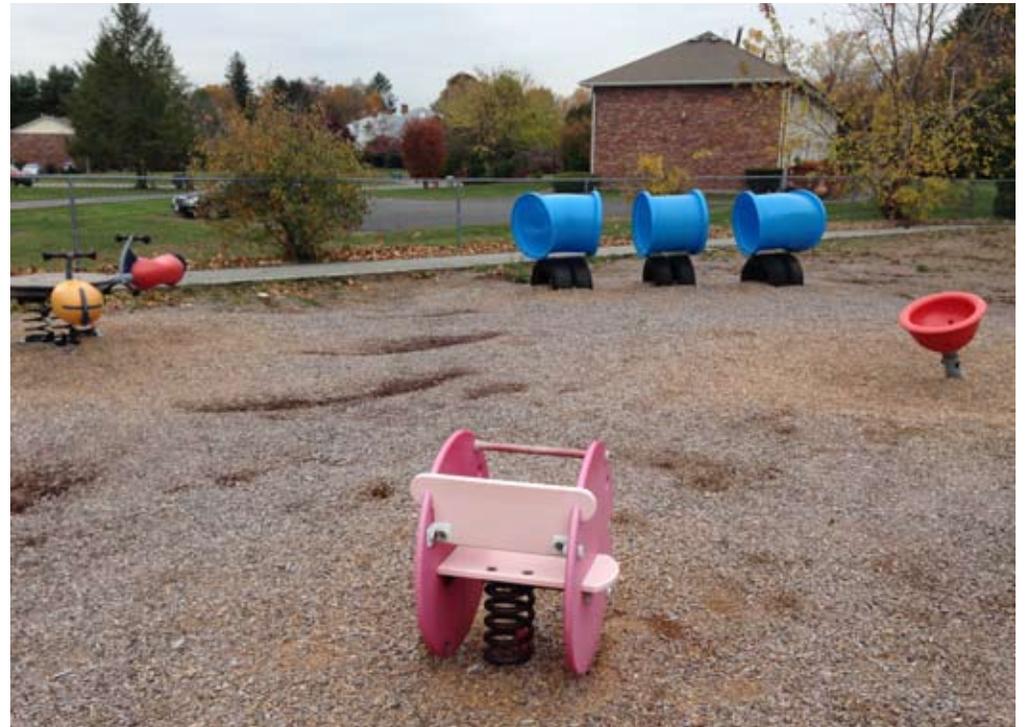
Item	Ranking	Comments
Play Equipment Safety	5	poor-multitude of safety issues including: bare metal in full sun; potential bolt projection/ laceration hazards; finger pinch hazards, loose and missing parts, bee holes, standing water, metal exposed in net cables, exposed concrete footings causing trip hazards
Play Equipment Condition	5	<u>wood playground</u> : poor and dated with many missing and deteriorated parts and hazards; <u>new age 5-12 equipment (Kompan Galaxy and Big Toys arched climber)</u> : excellent condition except for one sharp connection; <u>swings</u> : poor with rust and cracked coating on chains, missing seats, bent posts; <u>age 2-5 playground</u> : poor and dated with many missing and deteriorated parts and hazards
Play Equipment Universal Accessibility	5	non-compliance with 3 out of 4 areas due to age of structures
Play Diversity and Separation for age groups and activities	1	challenging; good play value; separation by age; underutilized age 2-5 area

Access to Playgrounds (accessible route)	4	safe accessible route to one of 4 play areas; no access between play areas
Play Surface Accessibility	4	appears to be engineered wood fiber surface which can be accessible when maintained correctly (raked, filled, compacted in layers); non-compliance evident in displaced fiber areas; compaction of fiber topping needed; wood chips can not be substituted
Play Surface Condition & Safety (extent, depth, drainage)	4	wood fiber surface varies from none to 12"+ depth; deficient depth and deep ruts at high use areas and throughout age 2-5 area; poor drainage in areas; deficient use zone around swings (need 2x ht) and slides > 6' ht; trip hazards with exposed footings; grass growing in many fiber areas
Surfacing Edge Condition & Safety	5	old wood - may be CCA treated, missing and deteriorated ties, wood fiber migrating out of areas; no edge at swings; drop from bituminous perimeter walk to play surface at age 2-5 area

General Playground Maintenance, Safety & Comfort	4	no trash or graffiti although multitude of maintenance issues noted for equipment and surfacing; close to access drive without barriers on 3 of 4 areas; broken gate and fencing on age 2-5 area; wood equipment appears to be in ball outfield; very few shade trees or canopies on equipment; missing age appropriate signage; no benches or tables

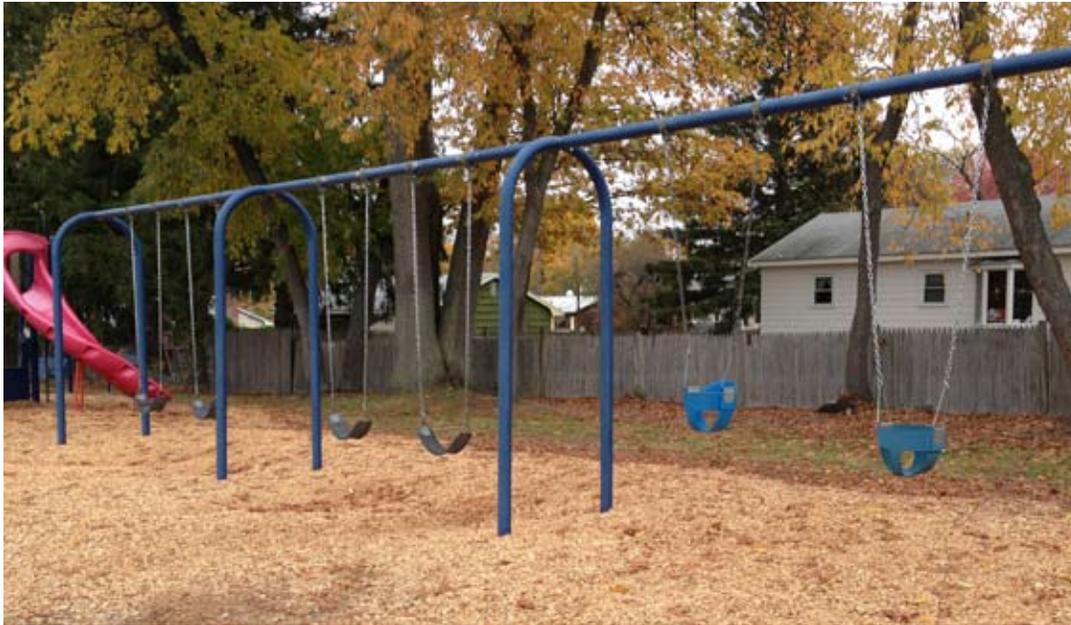
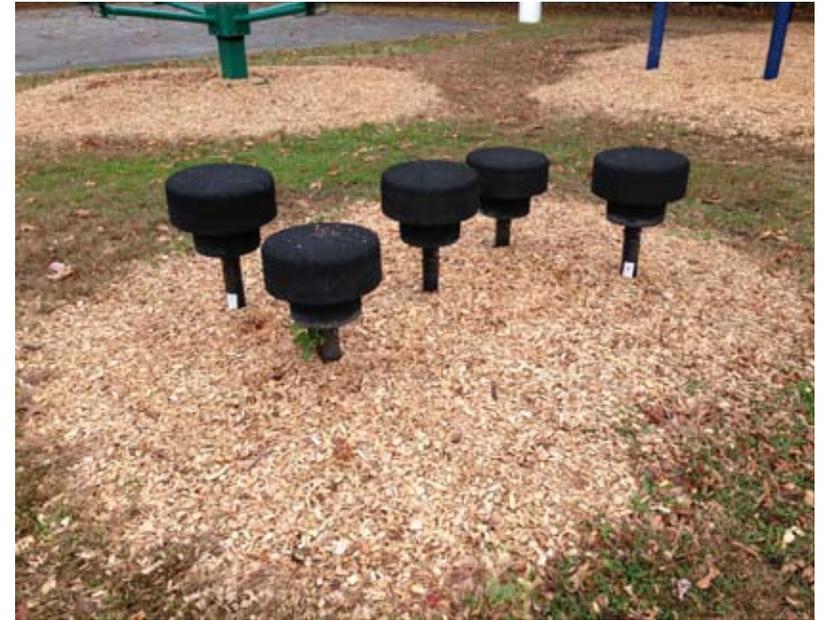
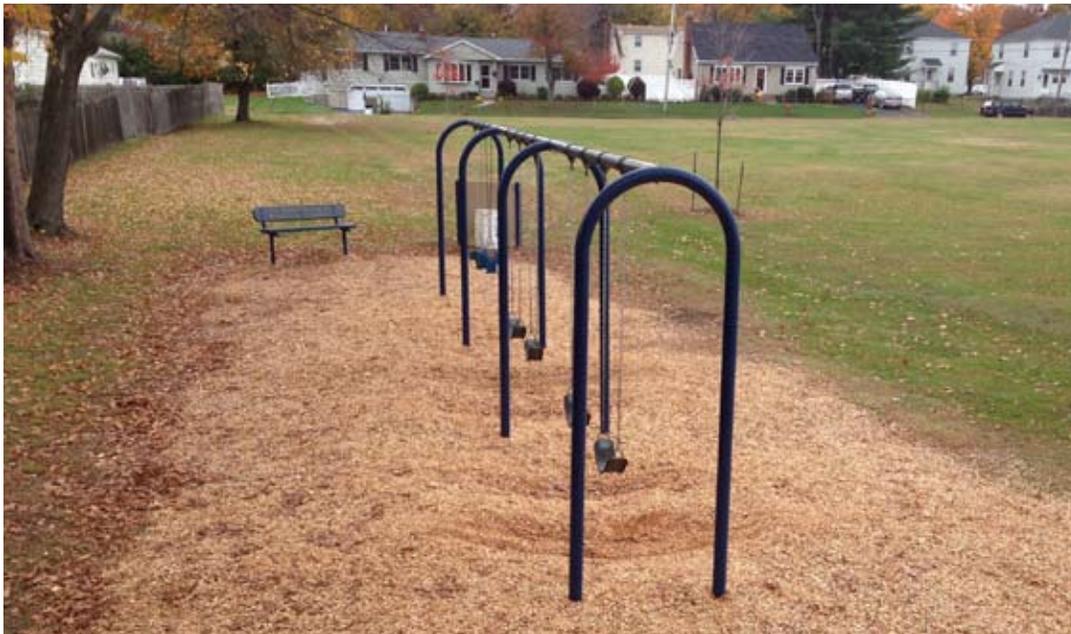
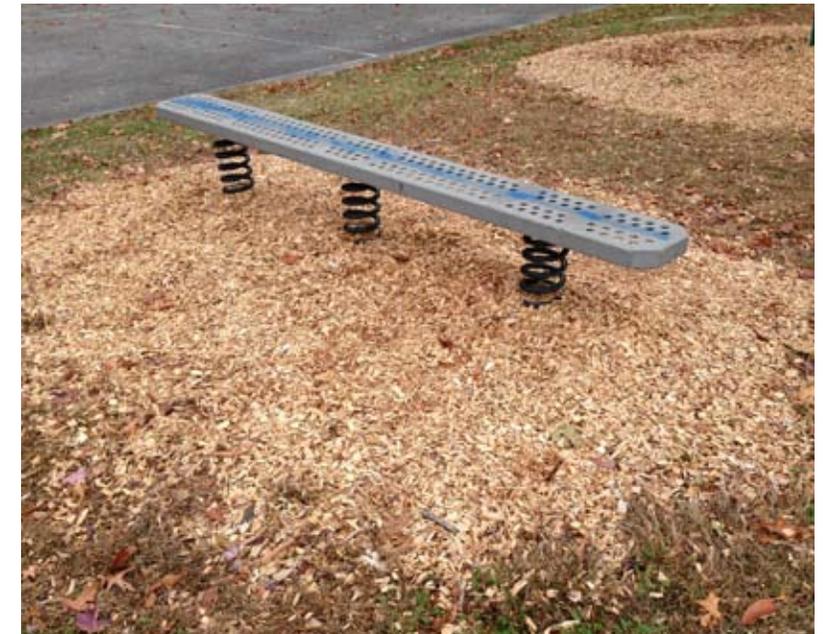
Item	Ranking	Comments
Play Equipment Safety	3	fair - missing and broken handholds on age 5-12 climber with sharp edges and protruding bolt hazards; missing top piece to cover bolts on 4-seat springer - base also exposed
Play Equipment Condition	2	new age 5-12 and 2-5 climbers (2004-2005) - excellent except for missing handhold hazards; 3 bays of swings with belt and toddler seats - excellent; 3 spring pieces in good condition - missing top piece on 4-seat springer
Play Equipment Universal Accessibility	1	good
Play Diversity and Separation for age groups and activities	2	challenging; great play value; ground level activities; separation by age and activity but lacks buffer areas
Access to Playgrounds (accessible route)	5	no accessible path between areas or from parking lot and street sidewalk - flat lawn
Play Surface Accessibility	5	appears to be wood chips which is not acceptable; additional non-compliance evident in displaced wood chip areas at swings and slides

Play Surface Condition & Safety (extent, depth, drainage)	5	wood chip surface is not as safe as wood fiber - 6" and less depth in general; deficient depth and deep ruts at slides and swings; deficient depth at 2-5 age equipment; deficient use zone around swings (need 2x ht), at age 2-5 equipment, at exercise bars, and at slides > 6' ht
Surfacing Edge Condition & Safety	5	no edge; loose wood surface migrating
General Playground Maintenance, Safety & Comfort	2	no trash or graffiti although maintenance issues noted for equipment and surfacing; age 2-5 equipment is too close to basketball court - also no barrier; shade from mature trees and small shade trees planted; canopies on equipment; 2-5 and 5-12 age signage; benches and picnic tables in shade

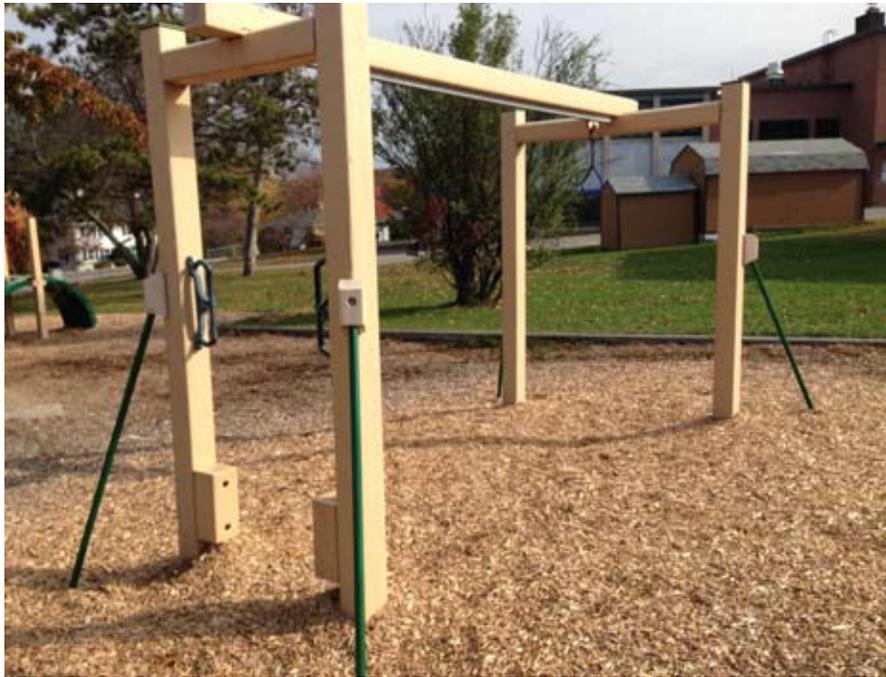
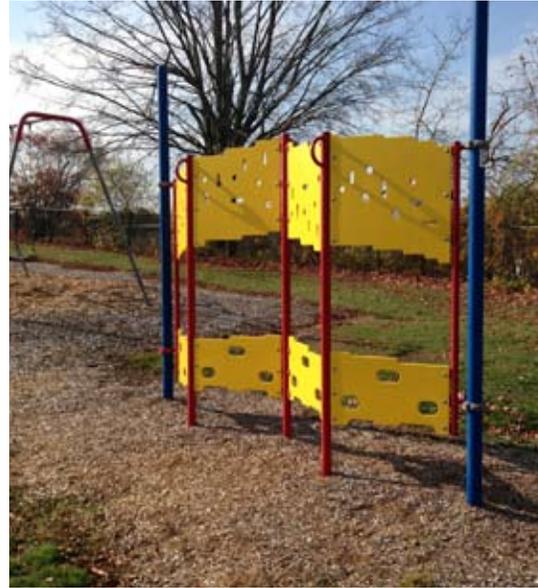
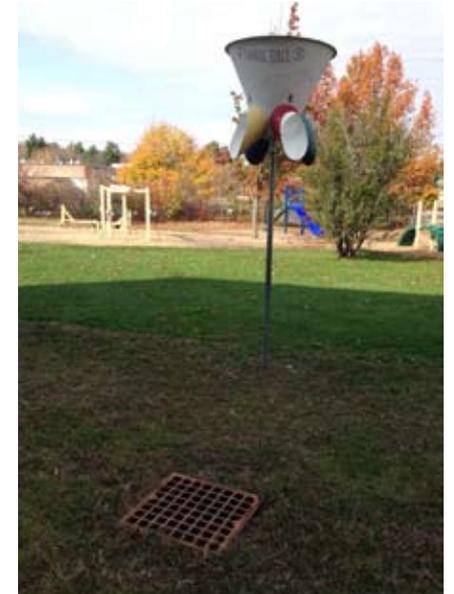
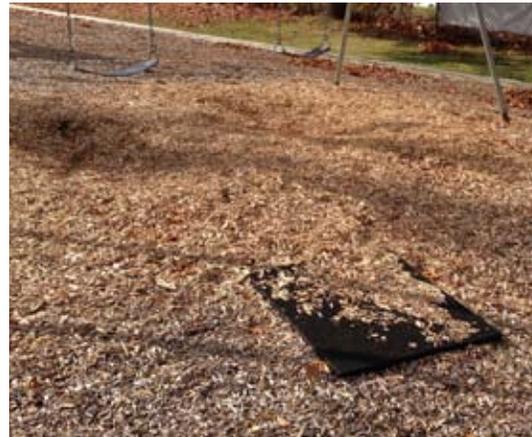
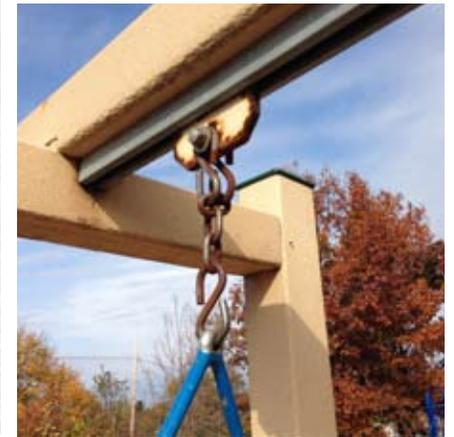
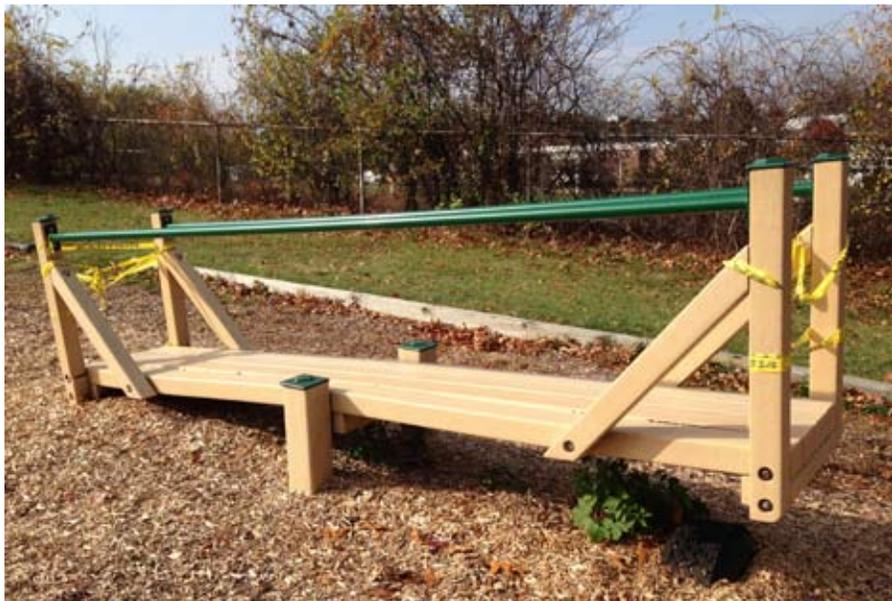
Item	Ranking	Comments
Play Equipment Safety	5	poor-multitude of safety issues including: cracked and broken see-saw; potential entanglement hazard at stand-alone slide and open 'S' hooks on rusty track slide and swing chains; bare metal in full sun; loose and missing parts
Play Equipment Condition	5	poor and dated (1997 ) with many cracked, missing and deteriorated parts and hazards; rust and worn coatings on platforms and handrails; bent posts; broken see-saw; missing tetherball;
Play Equipment Universal Accessibility	5	non-compliance due to age of structures
Play Diversity and Separation for age groups and activities	3	separation good; diversity poor with outdated climber, un-useable see-saw and slide track, limited options
Access to Playgrounds (accessible route)	5	no access - sloped lawn
Play Surface Accessibility	5	appears to be engineered wood fiber surface which can be accessible when maintained correctly (raked, filled, compacted in layers); non-compliance evident in displaced fiber areas; compaction of fiber topping needed; wood chips can not be substituted; level terraces are not connected with accessible route

Play Surface Condition & Safety (extent, depth, drainage)	4	wood fiber surface varies from none to 12"+ depth; deficient depth and deep ruts at high use areas and under climbers and slides; rubber mats have moved from swing areas; tree roots at lower swings; grass growing in areas; wet areas; deficient use zone around climbing wall; catch basin cover at ball throw is not safe
Surfacing Edge Condition & Safety	4	old wood - may be CCA treated, missing and deteriorated ties; plastic edge is broken and damaged throughout - some bolts are hazards; plastic edge between levels causes a trip hazard; no edge at upper swings and climbing wall - loose wood fiber is migrating
General Playground Maintenance, Safety & Comfort	4	no trash or graffiti although multitude of maintenance issues noted for equipment and surfacing; close to access drive without barriers for age 2-5 area; very few shade trees or canopies on equipment; missing age appropriate signage; no benches or tables
