# Town-wide Playground Assessments

Town of North Andover, Massachusetts

February 12, 2015

**Christine Scypinski, LEED AP  
Registered Landscape Architect**

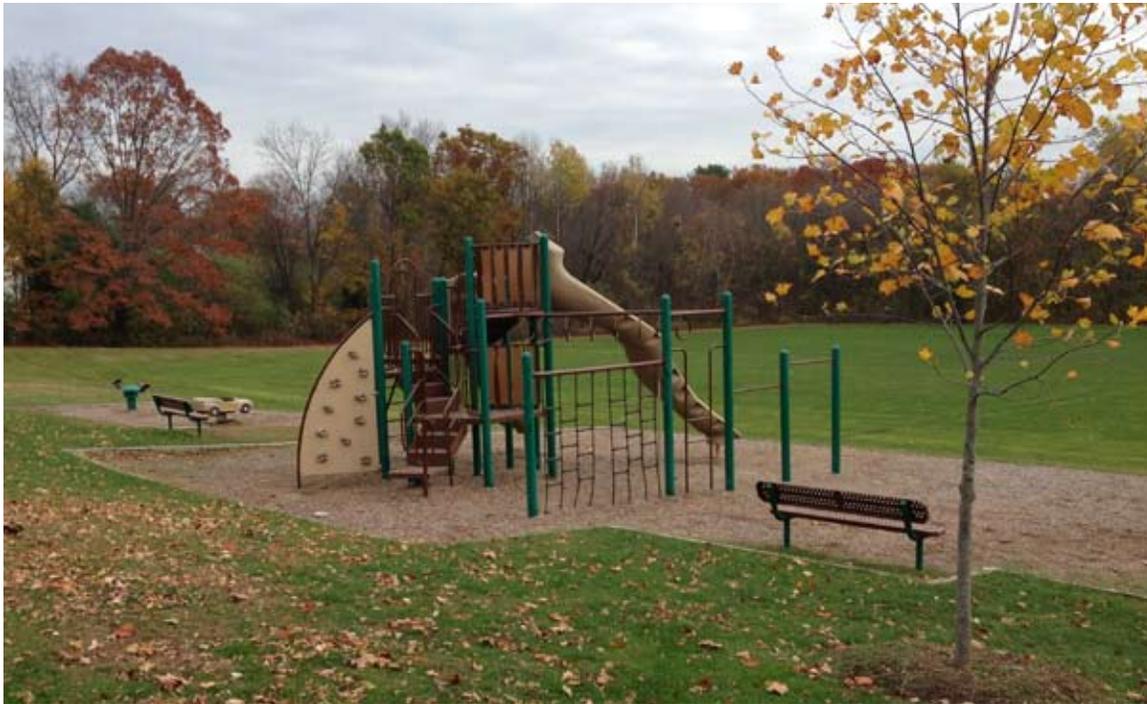
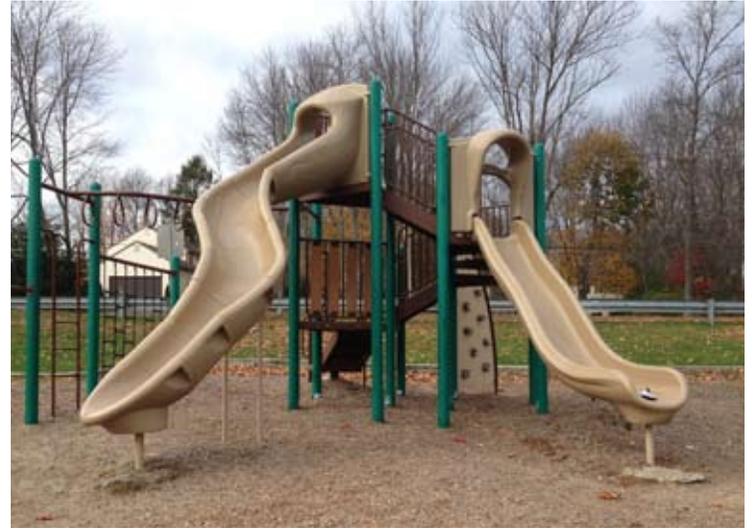
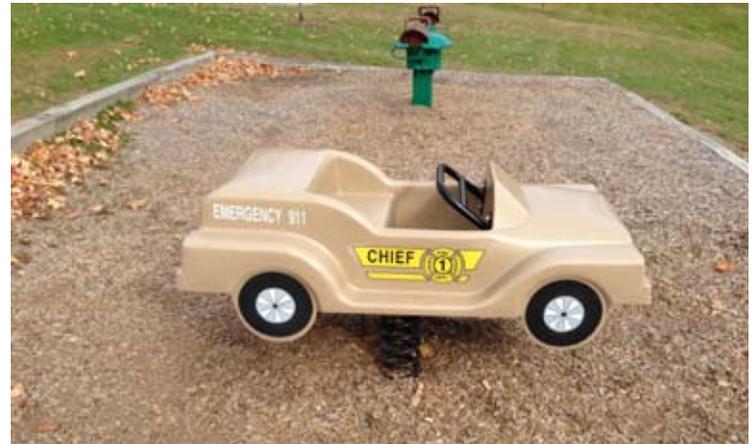
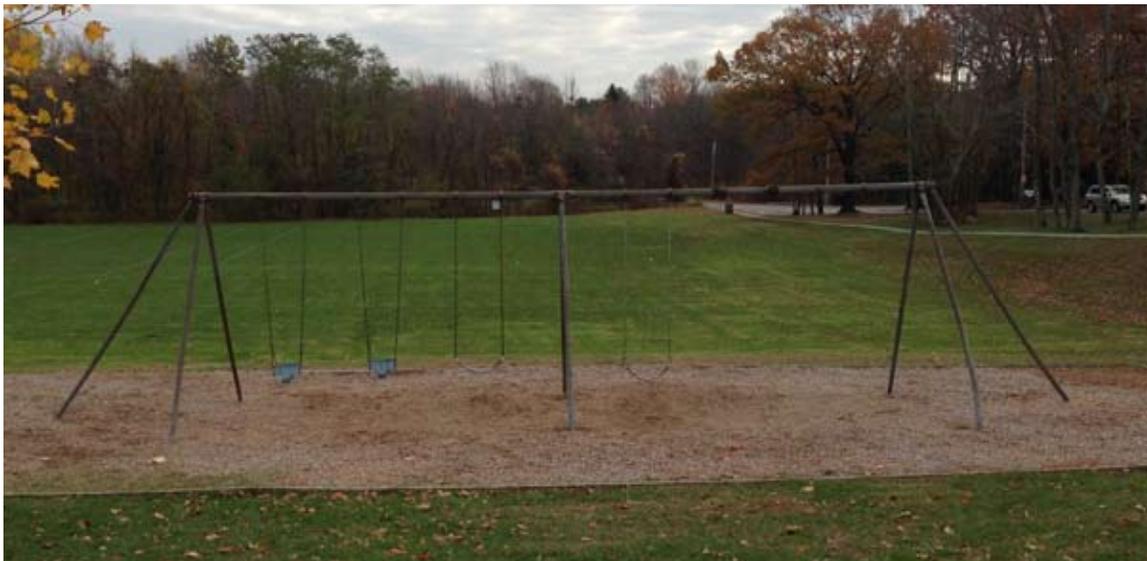
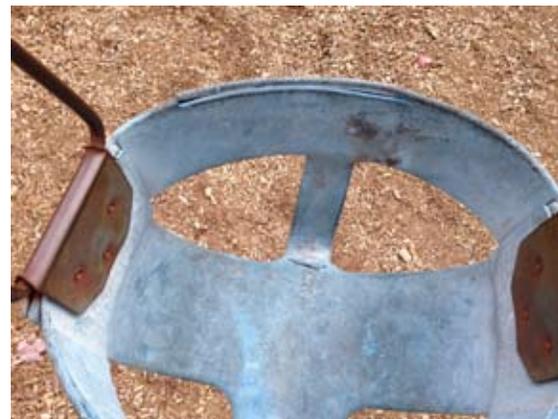
Item	Ranking	Comments
Play Equipment Safety	3	fair - exposed concrete footing at end of slide; open S hooks on swings; cracked swing seats
Play Equipment Condition	3	poor for swings - missing 2 seats and others are in poor condition with cracks, rust and open S hooks; climber and age 2-5 equipment are in good shape
Play Equipment Universal Accessibility	1	good
Play Diversity and Separation for age groups and activities	3	good play value; ground level activities; separation by age and activity but lacks buffer areas
Access to Playgrounds (accessible route)	5	no accessible path between areas or from parking lot - steep sloping lawn
Play Surface Accessibility	5	appears to be wood chips which is not acceptable; additional non-compliance evident in displaced wood chip areas at swings and slides
Play Surface Condition & Safety (extent, depth, drainage)	5	wood chip surface is not as safe as wood fiber - 10" and less depth in general; deficient depth and deep ruts at slides and swings; exposed concrete footings at end of 2 slides are hazards; deficient use zone around swings (need 2x ht); wet areas; grass growing

Surfacing Edge Condition & Safety	4	wood edge is old with some areas of deterioration
General Playground Maintenance, Safety & Comfort	3	no trash or graffiti although multitude of maintenance issues noted for equipment and surfacing; separation from road and parking with slope and guard rail; no shade; missing age appropriate signage; benches without shade

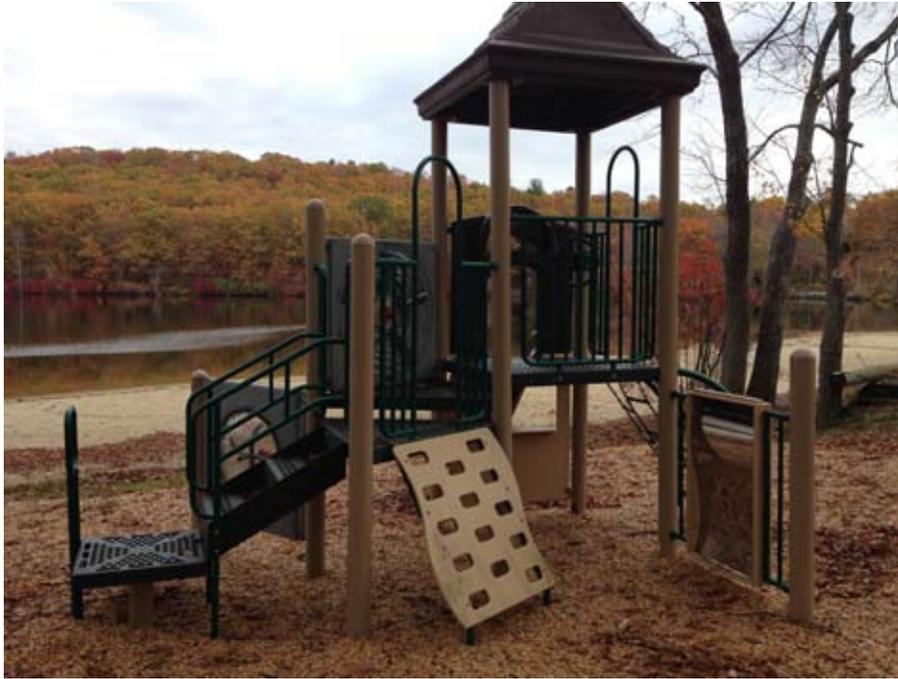
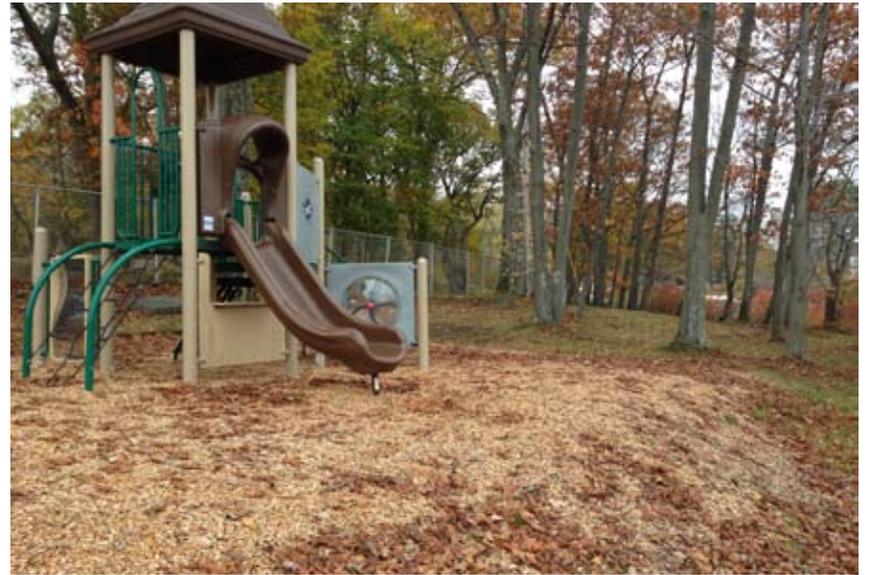
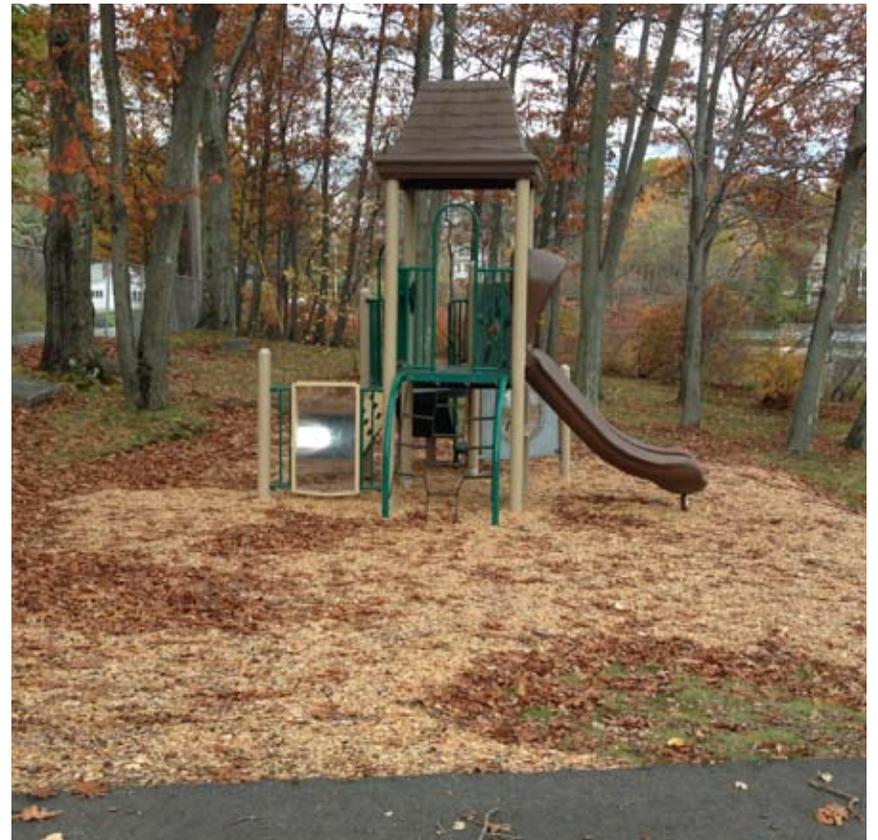
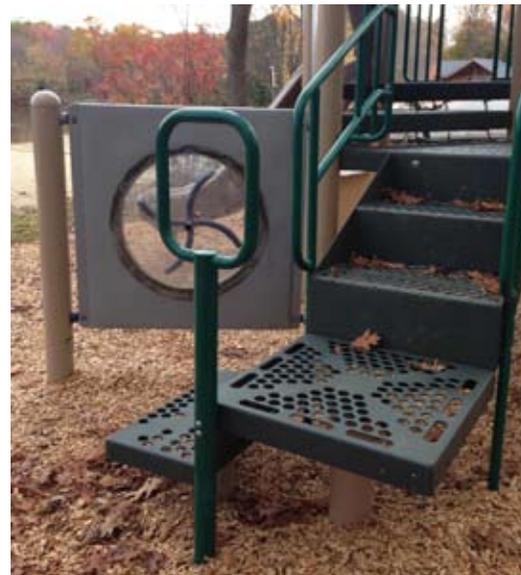
Item	Ranking	Comments
Play Equipment Safety	1	good
Play Equipment Condition	1	good - some mildew at Plexiglas panels
Play Equipment Universal Accessibility	1	good
Play Diversity and Separation for age groups and activities	4	fair to poor - small climber for age 5-12; ground level activities; no swings
Access to Playgrounds (accessible route)	5	wood chip surface from parking is not accessible due to material and slope
Play Surface Accessibility	5	appears to be wood chips which is not acceptable; additional non-compliance evident in displaced wood chip area at slide
Play Surface Condition & Safety (extent, depth, drainage)	5	wood chip surface is not as safe as wood fiber - 6" and less depth in general; deficient depth and deep ruts at slide; deficient use zone at slide - also sloped; grass growing
Surfacing Edge Condition & Safety	5	no edge - wood chips migrating
General Playground Maintenance, Safety & Comfort	2	no trash or graffiti although maintenance issues noted for surfacing; separation from road with fence but close to parking without barrier; very short use zone at slide exit and steep slope; shade from trees and canopies; 5-12 age signage; no benches

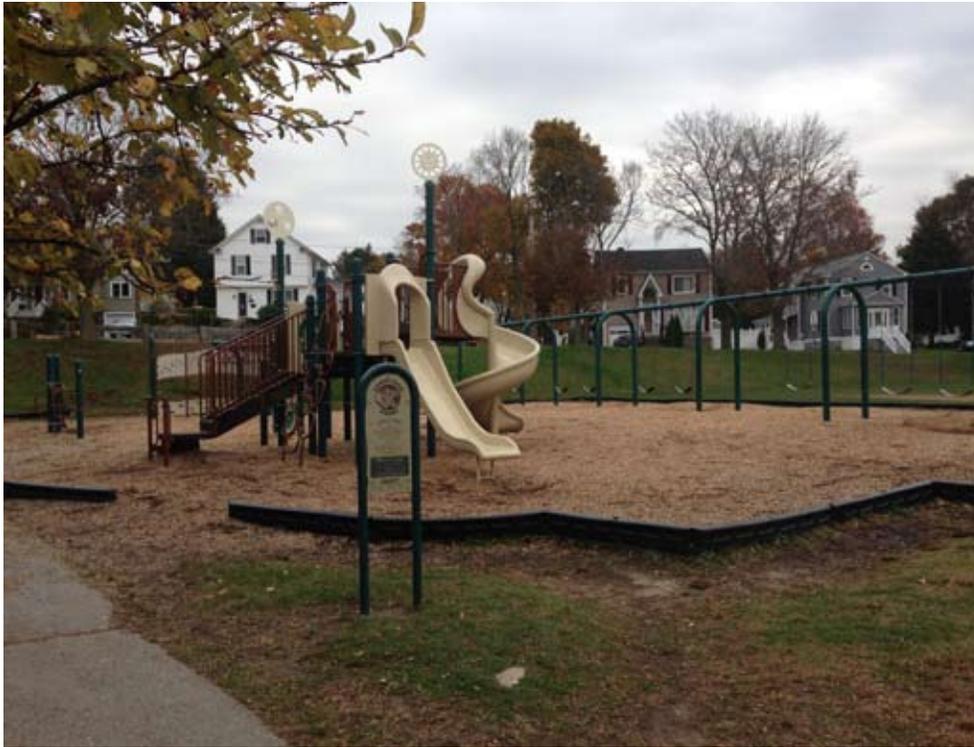
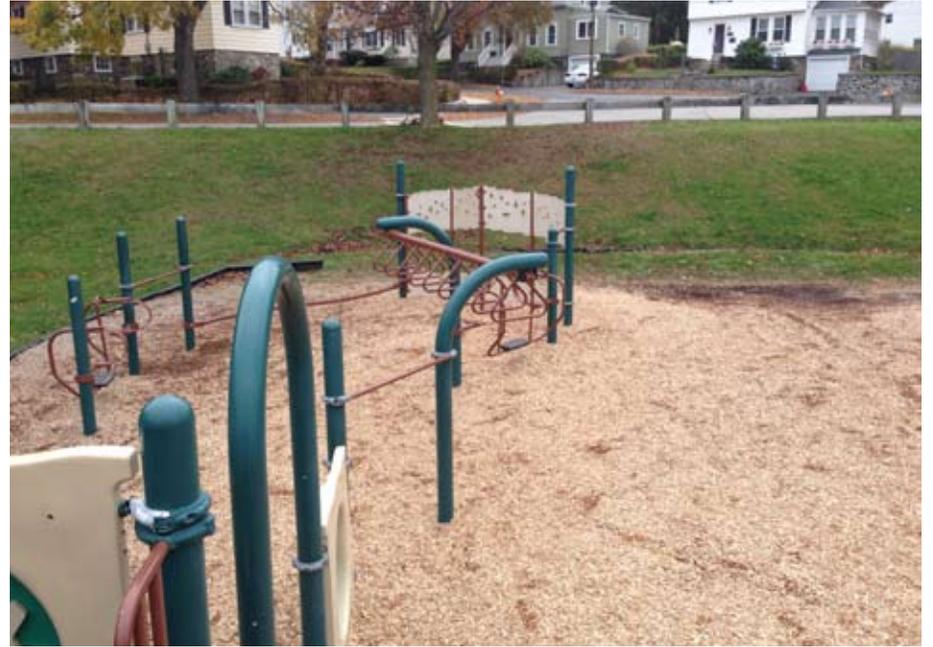
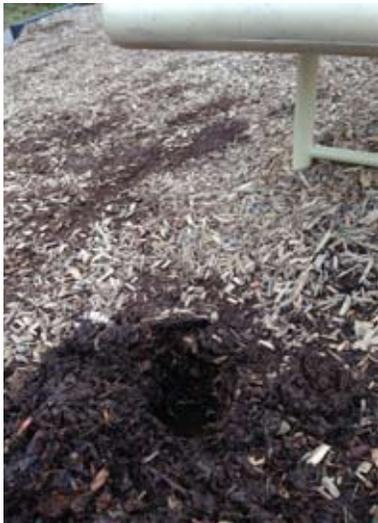
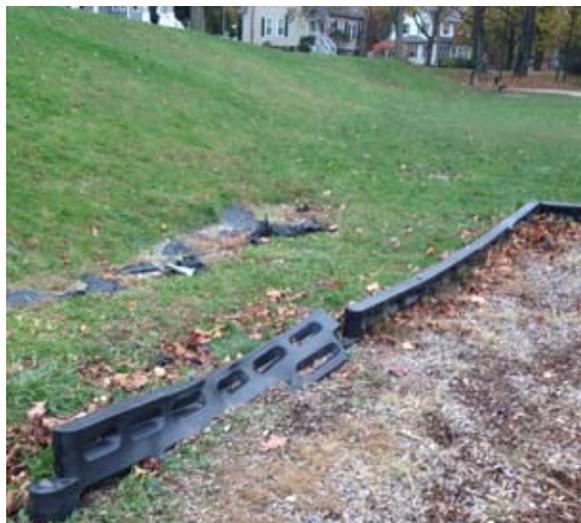
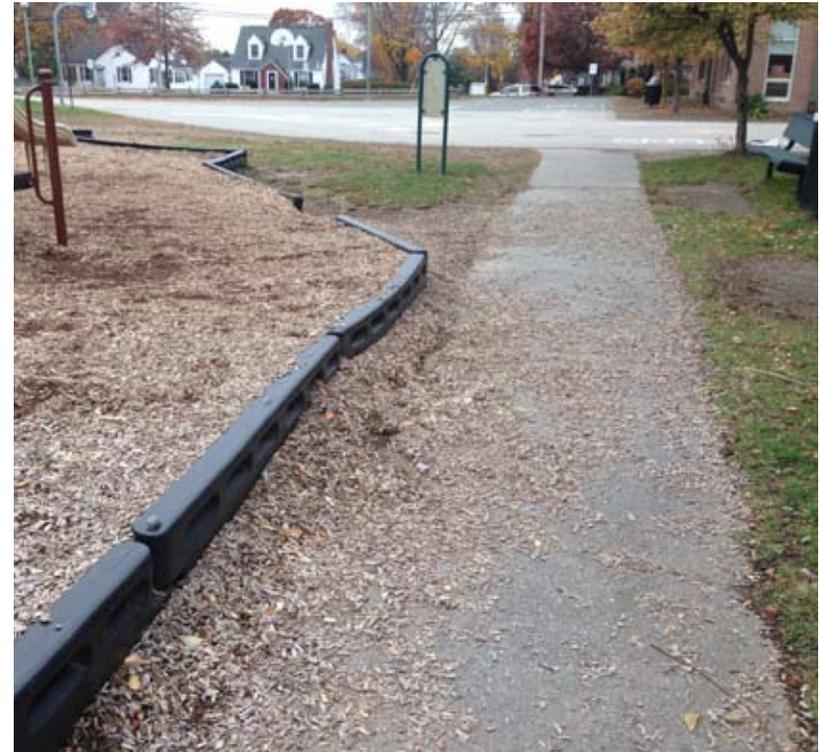
Item	Ranking	Comments
Play Equipment Safety	2	minor maintenance issues; bare metal on balance beams in full sun; rubber steps on pieces worn to metal; belt swing missing; some rust starting and coating on steps peeling
Play Equipment Condition	2	good - minor maintenance issues
Play Equipment Universal Accessibility	1	good
Play Diversity and Separation for age groups and activities	1	challenging; good play value; separation of swings
Access to Playgrounds (accessible route)	2	accessible path from school but in poor shape with spill over of mulch on bituminous walk
Play Surface Accessibility	4	appears to be engineered wood fiber surface which can be accessible when maintained correctly (raked, filled, compacted in layers); non-compliance evident in displaced fiber areas; compaction of fiber topping needed; wood chips can not be substituted
Play Surface Condition & Safety (extent, depth, drainage)	4	wood fiber surface 12"+ depth in general; deficient depth and deep ruts at swings and slides; poor drainage in areas with ground water just below the surface; grass in areas

Surfacing Edge Condition & Safety	4	plastic edge with damaged and missing sections; protruding bolts causing hazards
General Playground Maintenance, Safety & Comfort	2	no trash or graffiti although maintenance issues noted for surface, no sun protection on south sides or equipment, age 5-12 signage, benches but in poor shape and without shade
