NORTH ANDOVER RECOMMENDED FACILITIES MASTER PLAN

Town of North Andover, MA

Consultant Team:
The Cecil Group, Inc.
HMFH Architects
Foley Buhl Roberts & Associates
Garcia Galuska DeSousa Consulting Engineers Inc.

May 2012

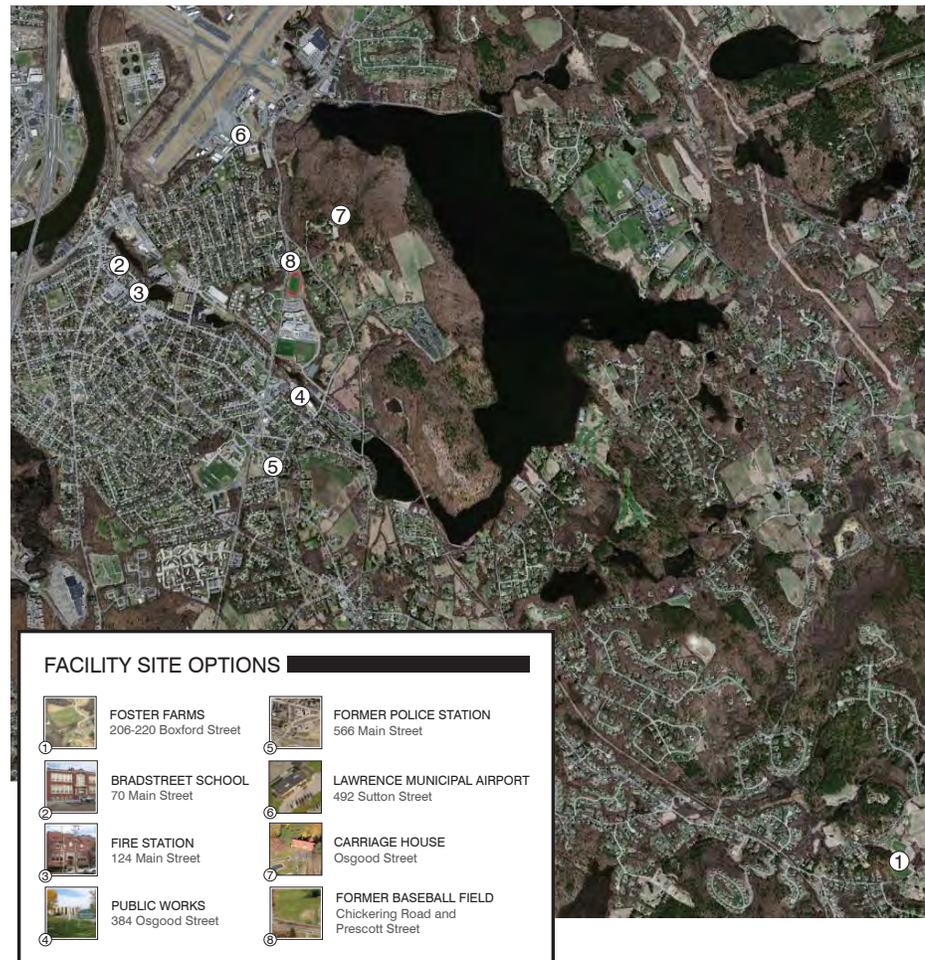
Figure 3.1 Facility Site Options

The consultant team examined the sites of three Town buildings: Bradstreet School, Former Police Station and Municipal Garage Facility. Each of the sites was evaluated based on their condition and capacity to support municipal uses. The assessments took into consideration a wide range of characteristics and criteria, including size, zoning, compatibility with surrounding areas and potential impact on adjacent areas. The consultant team also looked at how each site could be reconfigured or better utilized.

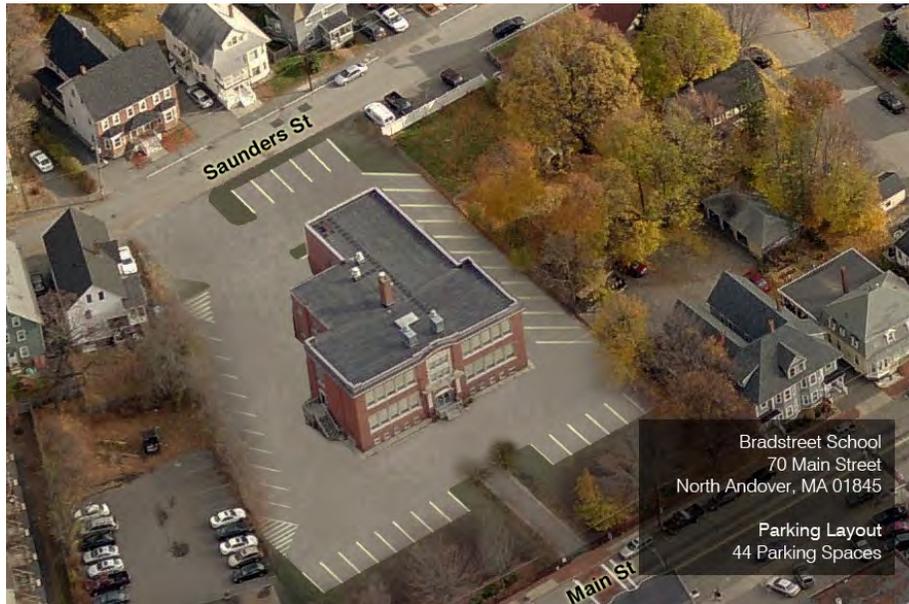
Figure 3.2 Bradstreet School

This former school, set back from Main Street, was identified in the meetings as an iconic building that deserves preservation and reuse. It has been used for various purposes and has not remained vacant for very long periods. The building is separated from Main Street by a wrought iron fence and a buffer area with vegetation, and there is a main entrance path running through the center of the buffer to the building. Within the vegetated buffer are several mature maple trees and open, unused areas. A paved apron surrounds the building for parking spaces and driveways. Most of the paved area has a chain link fence separating the property from the streets and adjacent properties. The rear of the property provides vehicle access to the site from Saunders Street. Nine car parking spaces are located on the street side of the chain-link fence that separates the school property from Saunders Street.

- Location: 70 Main Street
- Size: 1.15 acres
- Owner: Town of North Andover
- Zoning: General Business District
- Existing Conditions: Vacant 19,500-square-foot building used for Fire Department training exercises, with parking to the north and west of the facility

- Access: Main Street and Saunders Street
- Assessed Value: \$1.89 million
- Site Plan: The parking lot around the building could be reconfigured to include 44 spaces as shown in Figure 3.2.

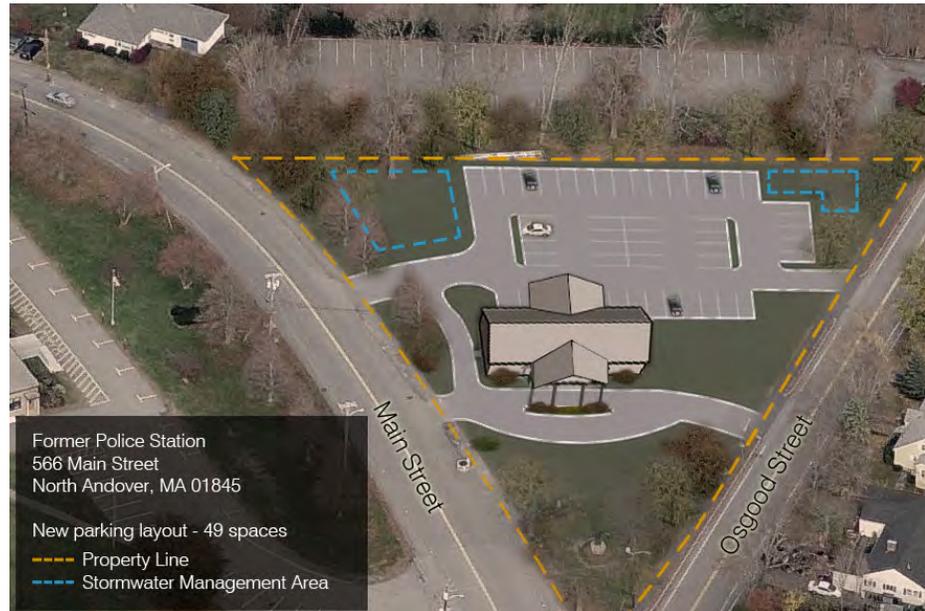
Figure 3.3 Former Police Station

The former Police Station is located at the intersection of Main Street and Osgood Street, within a triangular piece of property that includes a memorial at the apex. The property is located across Main Street from Kittredge Elementary School and across Osgood Street from residential homes. The grade of the property drops steeply towards the rear across the building foundation, allowing the lower floor to daylight at the back of the building where the main parking lot is situated. Approximately 45 parking spaces were counted in the rear of the property, and a temporary building has been sitting at the rear of the building. Beyond a landscape buffer along the rear property line is a parking lot for a multi-unit residential care center.

- Location: 566 Main Street
- Size: 1.57 acres
- Owner: Town of North Andover
- Zoning: Residence 4 District
- Existing Conditions: Vacant 6,000-square-foot building, with a parking lot to the north of the facility
- Access: Main Street and Osgood Street (two accesses on each street)
- Assessed Value: \$1.24 million
- Site Plan: The parking lot north of the building could be reconfigured to include 49 spaces as shown in Figure 3.3.

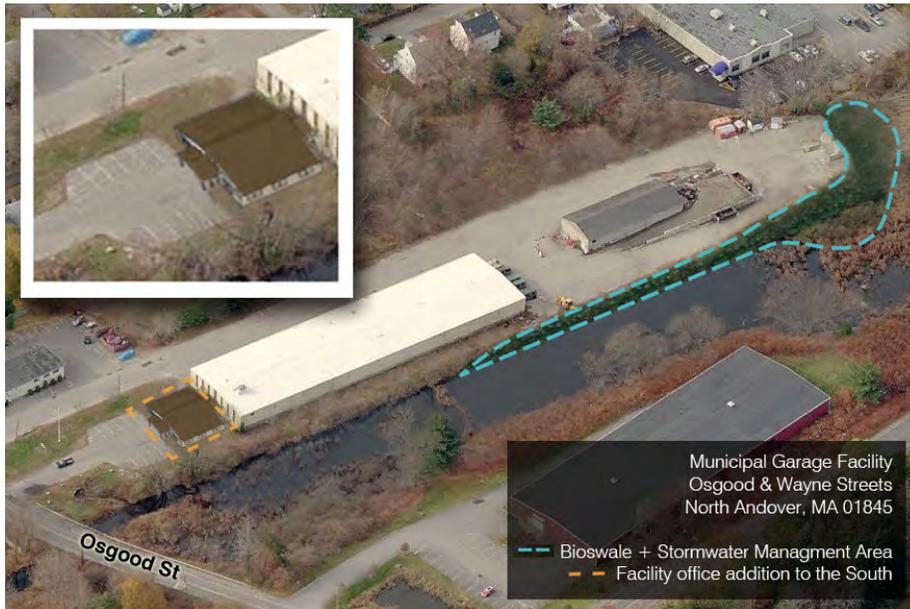
Figure 3.4 Municipal Garage Facility

The Municipal Garage Facility is a deep property that fronts on the west side of Osgood Street and lies along a braided stream that drains from Stevens Pond. The front of the lot is a paved parking lot with about 20 spaces, and the rear of the parcel is unpaved. The buildings, garages and salt storage shed are located in the center of the property with adjacent access and storage. A right-of-way runs on the south side of the property. Access into the property is either through the center driveway, which provides access to the parking lot in front of the building, or through the south-side right-of-way, which provides access into the garage and rear of the property. While most of the property is surrounded by other industrial and commercial properties, residential homes on Concord Street back up to the property. There is no paving between the main garage building and the stream.

- Location: 384 Osgood Street
- Size: 3.59 acres
- Owner: Town of North Andover
- Zoning: Residence 4 District
- Existing Conditions: Public Works maintenance, storage and administrative building, with parking to the north, west and south of the facility
- Access: Osgood Street
- Assessed Value: \$1.61 million
- Site Plan: The site is large enough to accommodate the addition of an office facility to the south of the existing building, as shown in Figure 3.4.

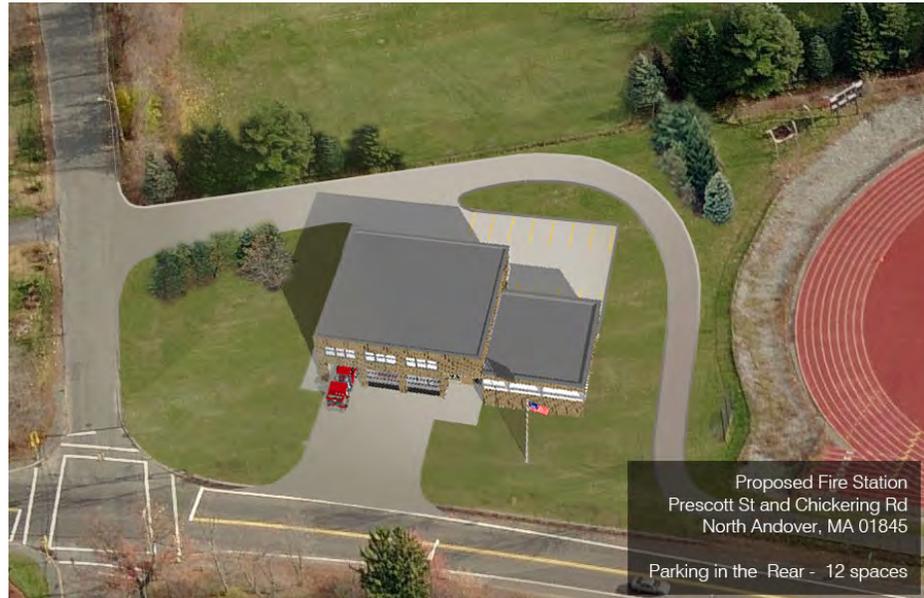
Figure 3.5 Prescott Street/Chickering Road Parcel

This parcel was previously indicated by the Town as a section of the High School property suitable for a future public safety facility. The parcel is flat and currently has a softball-sized baseball field located on it. Behind the property are the North Andover High School track and field facilities, and beside the property is open residential property. An access drive from Prescott Street runs through the site to the High School track and field facilities, and the access continues onto the High School parking lot.

- Location: Prescott Street and Chickering Road
- Size: 3.84 acres (Only a portion of this parcel would be developed into a new fire station.)
- Owner: Town of North Andover
- Zoning: Residence 2 District
- Existing Conditions: Vacant property/field north of the North Andover High School track
- Access: None
- Assessed Value: \$218,900
- Site Plan: This site has been designated for the future construction of a public safety facility. It is well suited for a new Fire Department Headquarters. As shown in Figure 3.5, a new fire station could be accessed from both Prescott Street and Chickering Road. A parking lot with 12 spaces could be located behind the building.

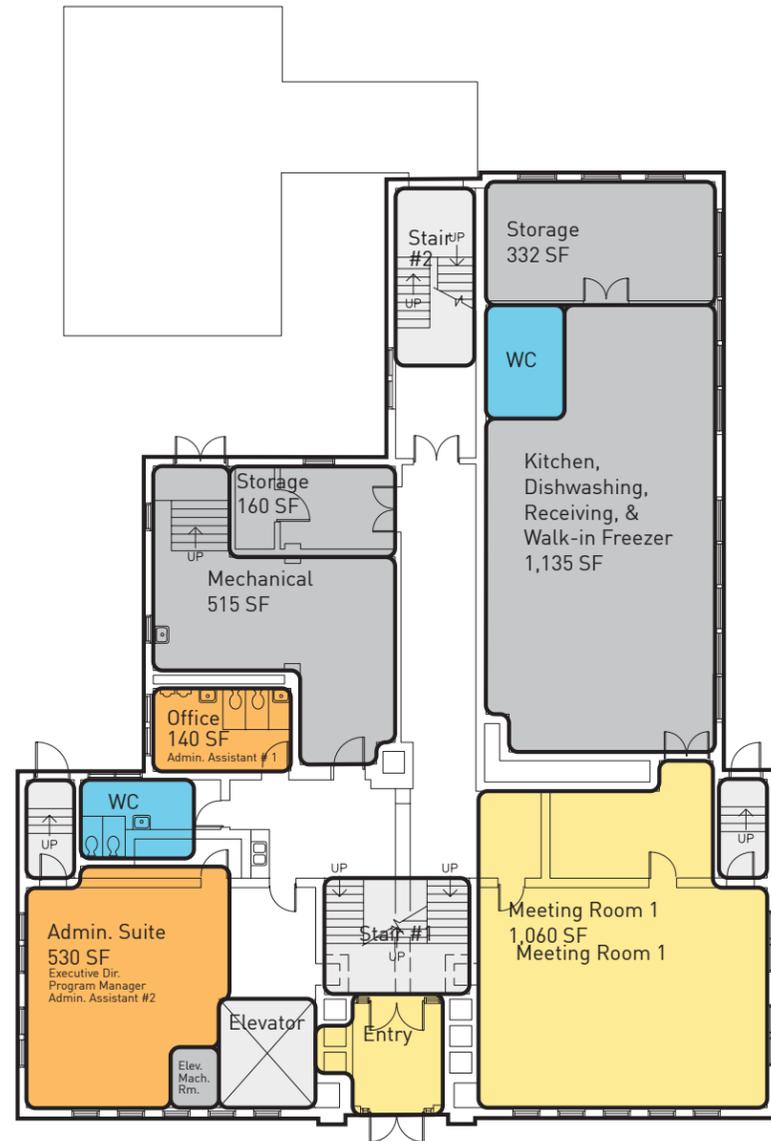
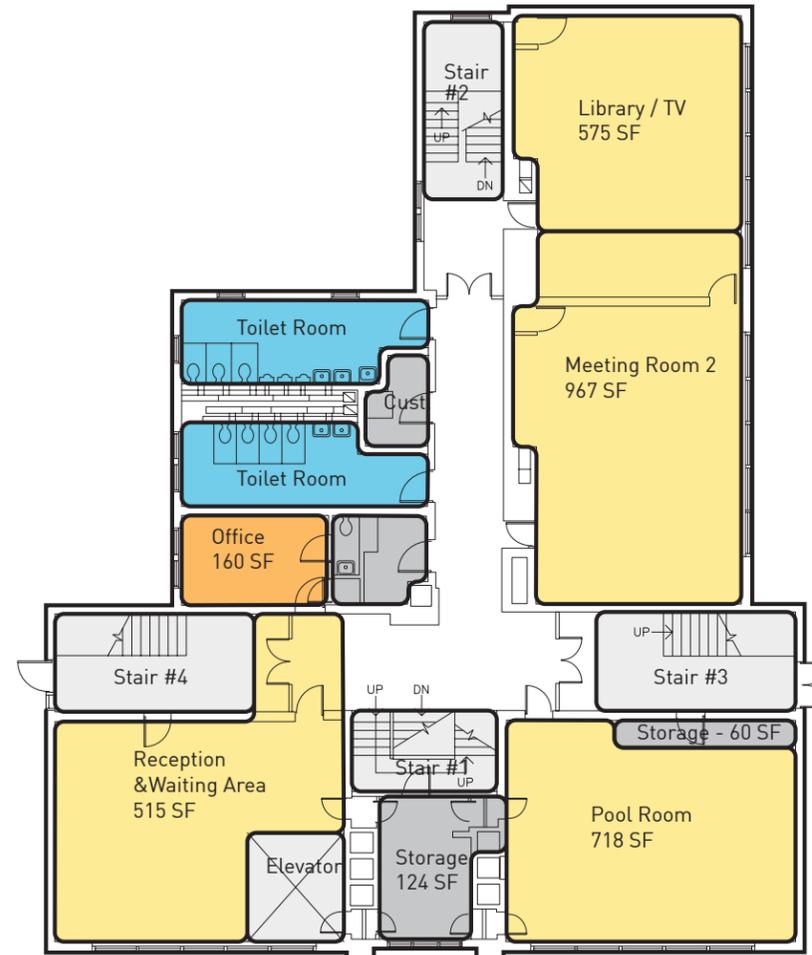
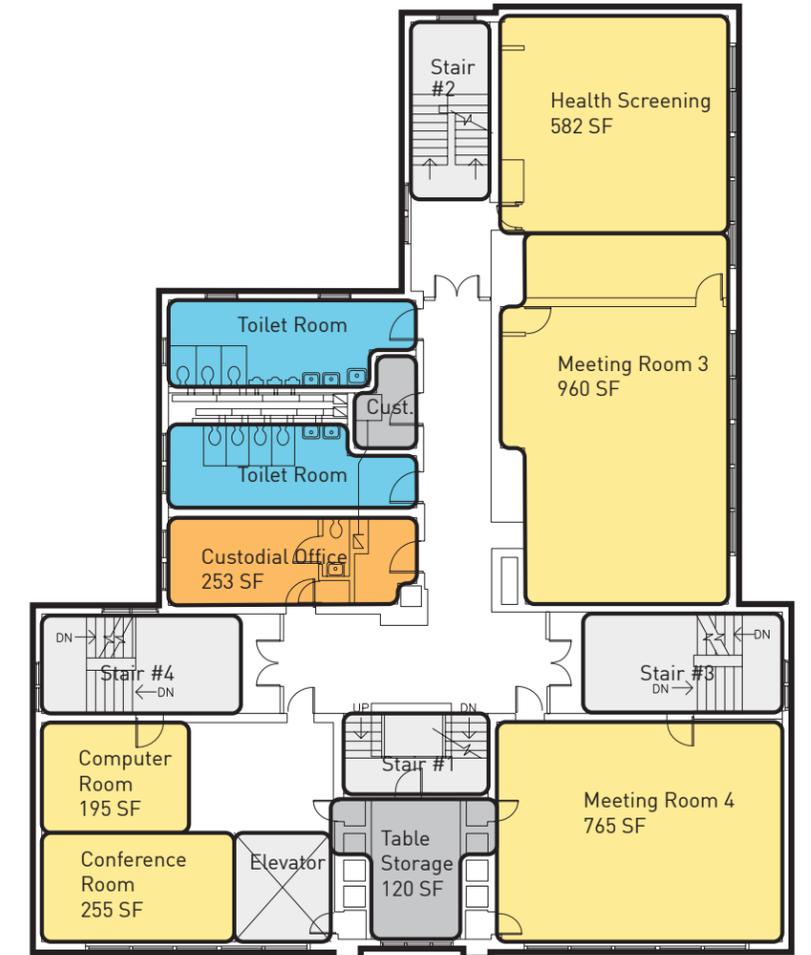
Figure 3.6 Bradstreet School Fit Study - Senior Center

Basement Plan

First Floor Plan

Second Floor Plan

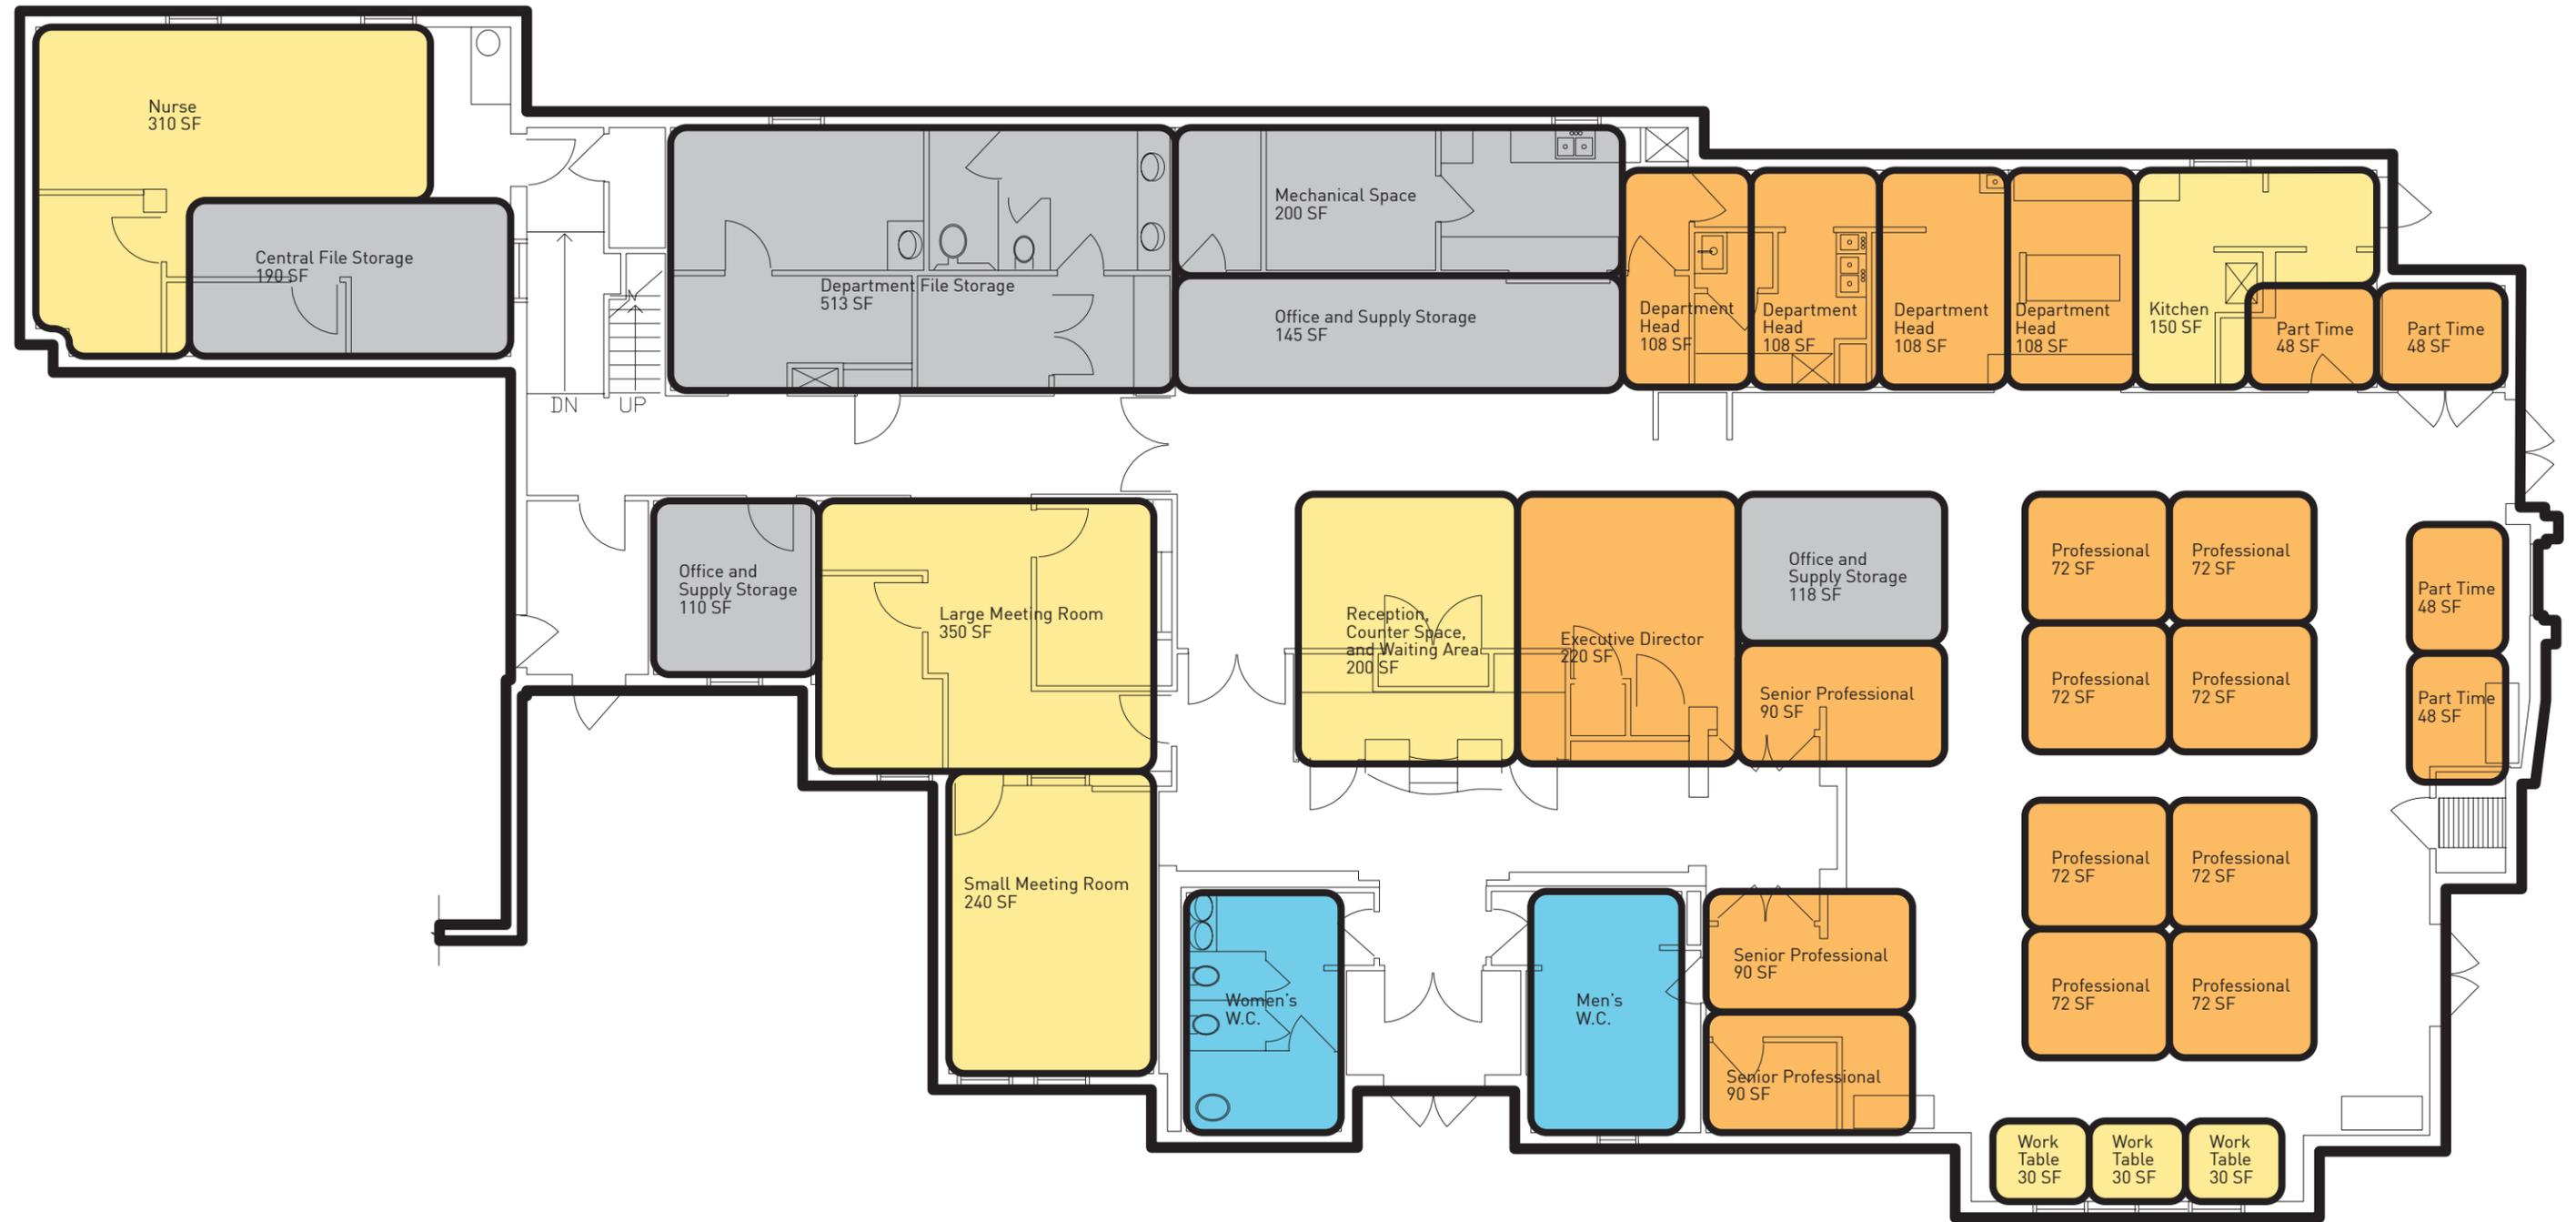
Figure 3.9 Senior Center Fit Study - Community Development Division and School Department

The Senior Center at 120 R Main Street could easily fit the Community Development Division or the School Department Administration as shown in Figures 3.9. For either department, there would be ample space for offices, storage, meeting rooms and work spaces. The meeting rooms would provide options for modular office systems that could be arranged and expanded, as needed.

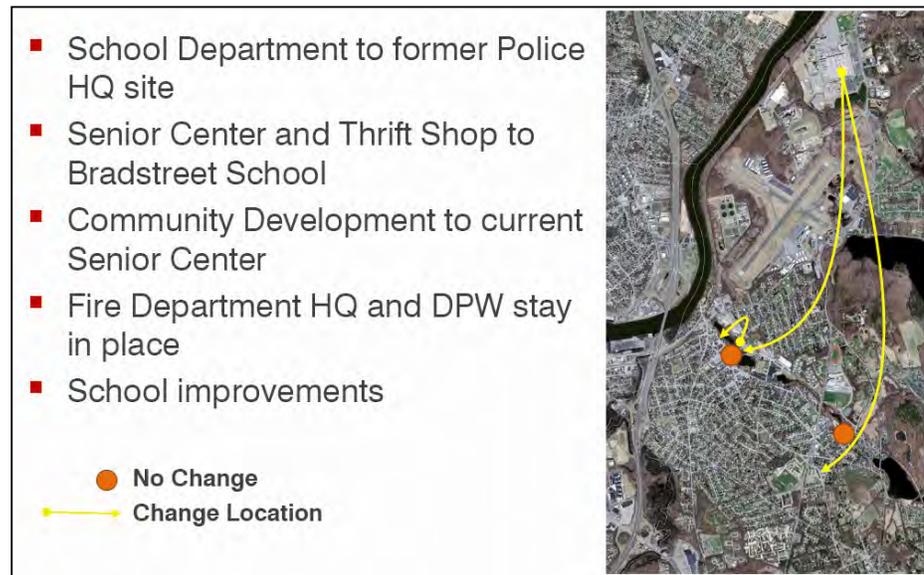
Figure 4.1 Alternative Scenario No. 1: Use/Reuse of Existing Buildings.

The School Department Administration would move from its leased space at 1600 Osgood Street to the former Police Station site at 566 Main Street, and the Senior Center and Thrift Shop would move from Main Street to the Bradstreet School site at 70 Main Street. The Community Development Division would move to the current Senior Center site behind Town Hall.

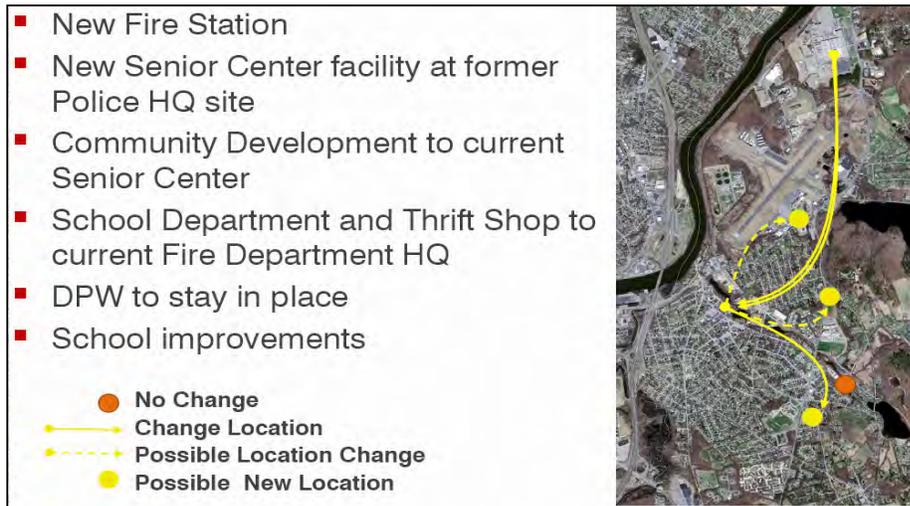
Figure 4.4 Alternative Scenario No. 4: New Fire Station and Senior Facilities

ment Division would move from 1600 Osgood Street to the current Senior Center site at 120 R Main Street. As in all scenarios, the Public Works Department would remain in its current location, and school improvements would be made.

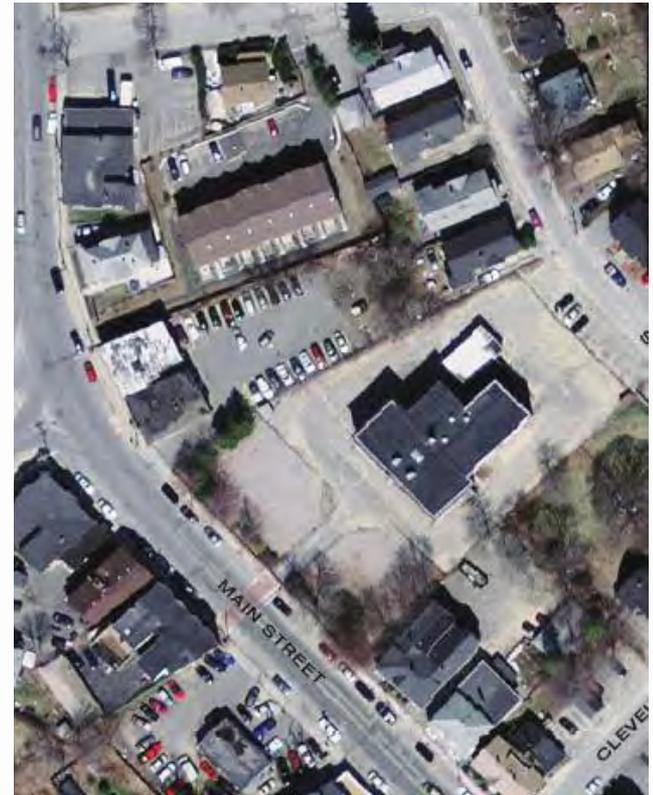
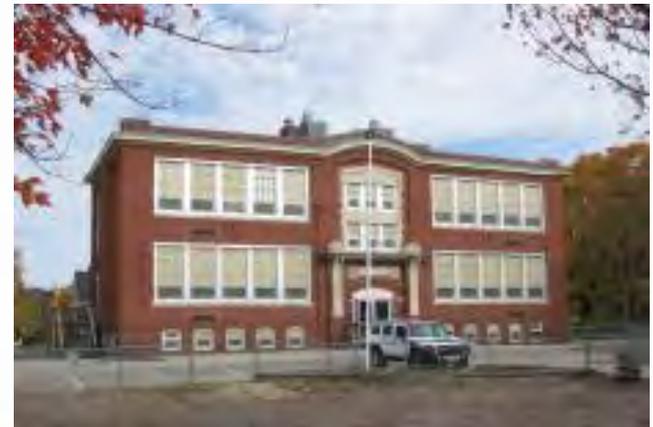
Bradstreet School

- Not ADA compliant
- New HVAC required
- New electric system required
- New life safety systems required
- Fire protection systems serviceable
- Gas systems serviceable

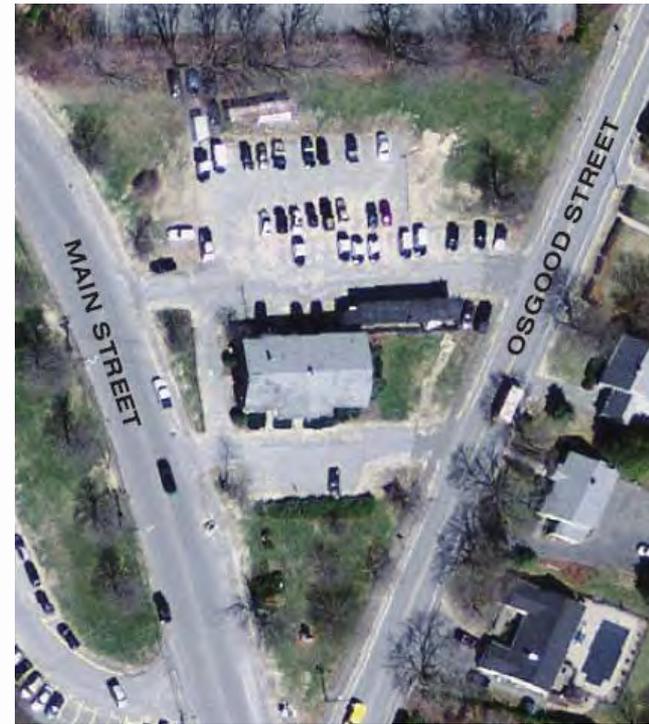
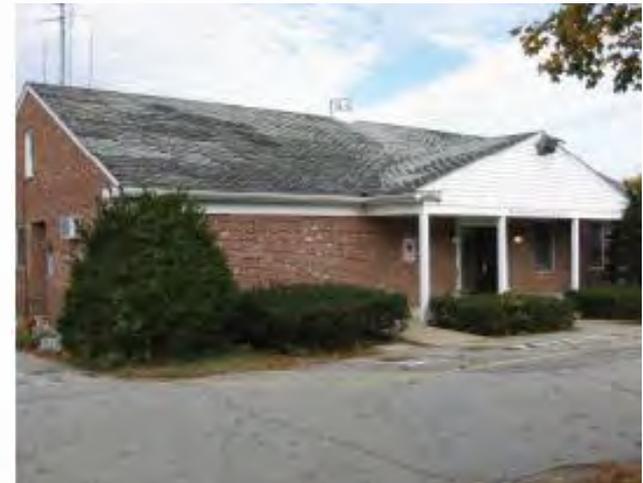
Former Police HQ

- Not ADA compliant
- Lift required
- Roof replacement required
- Repointing required
- Electrical system serviceable
- Gas system serviceable
- HVAC upgrade required

- Not ADA compliant
- Lift required
- Roof replacement required
- Repointing required
- Electrical system serviceable
- Gas system serviceable
- HVAC upgrade required

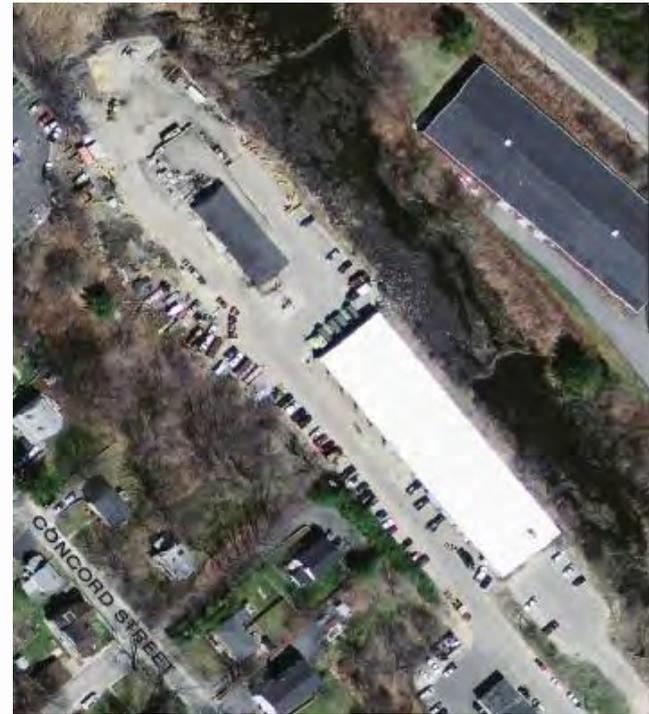
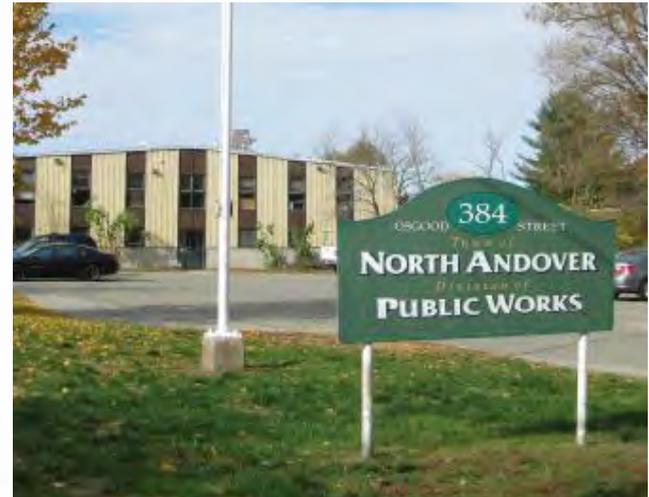
- Not ADA compliant
- Floor slab improvements required
- New HVAC required
- Upgrade of plumbing required
- New electric system required
- Upgrade of fire protection and life safety systems required

The Public Works building has a steel frame with metal panel exterior walls and a metal roofing system. There are 11 garage doors on the west side; the opposite side has no windows or doors. The building's age is starting to show, with some insulation falling away and settlement collecting in the interior masonry walls. Major issues and needed repairs include the following:

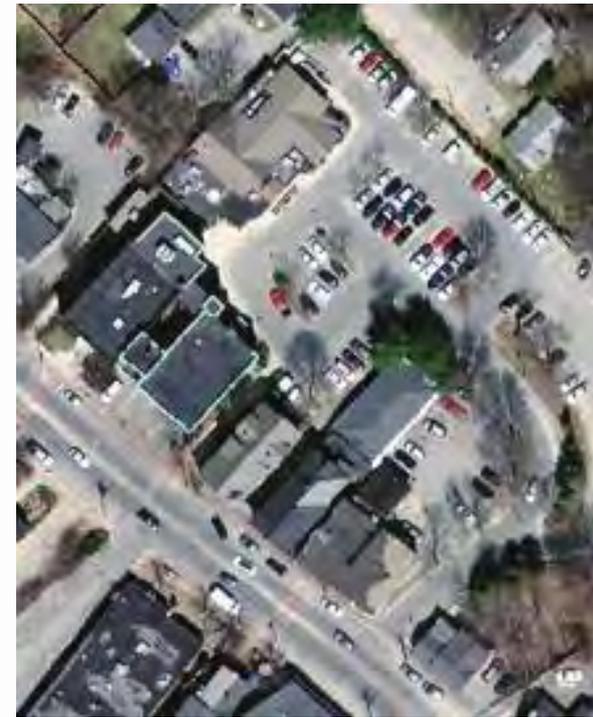
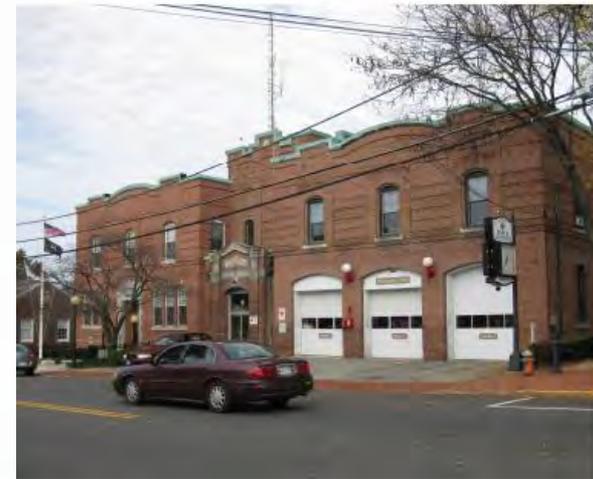
Fire Department

- Not ADA compliant
- Window replacement required
- Floor repairs required
- Repointing required
- Upgrade electrical systems required
- Upgrade plumbing systems required
- Upgrade to HVAC system required

- Not ADA compliant
- Window replacement required
- Floor repairs required
- Repointing required
- Upgrade electrical systems required
- Upgrade plumbing systems required
- Upgrade to HVAC system required

In addition to these needs, the basement slab should be repaired or replaced because it has a number of cracks and pits. The fire alarm system and life safety systems should be upgraded, and the stair railings need to be made ADA compliant.

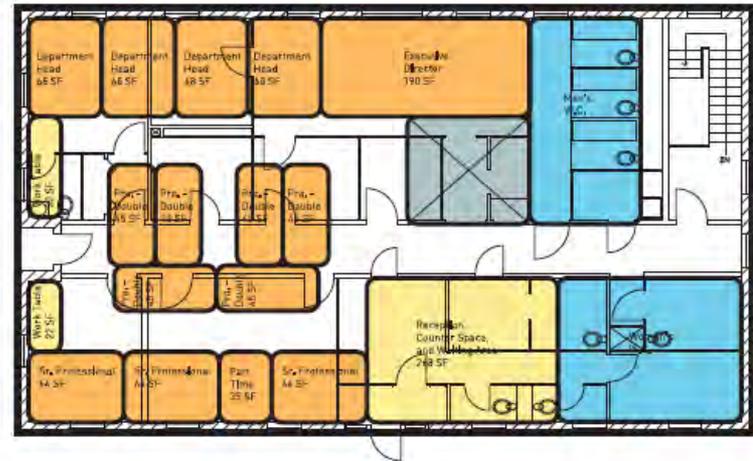
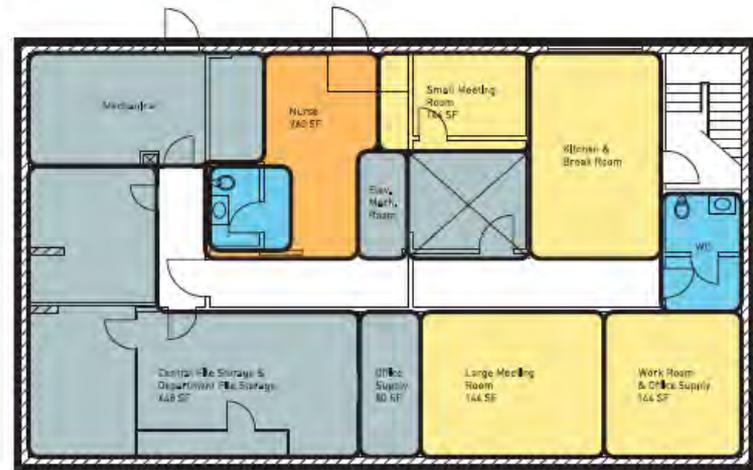
- Former Police Station Floor Plan with Community Development Offices

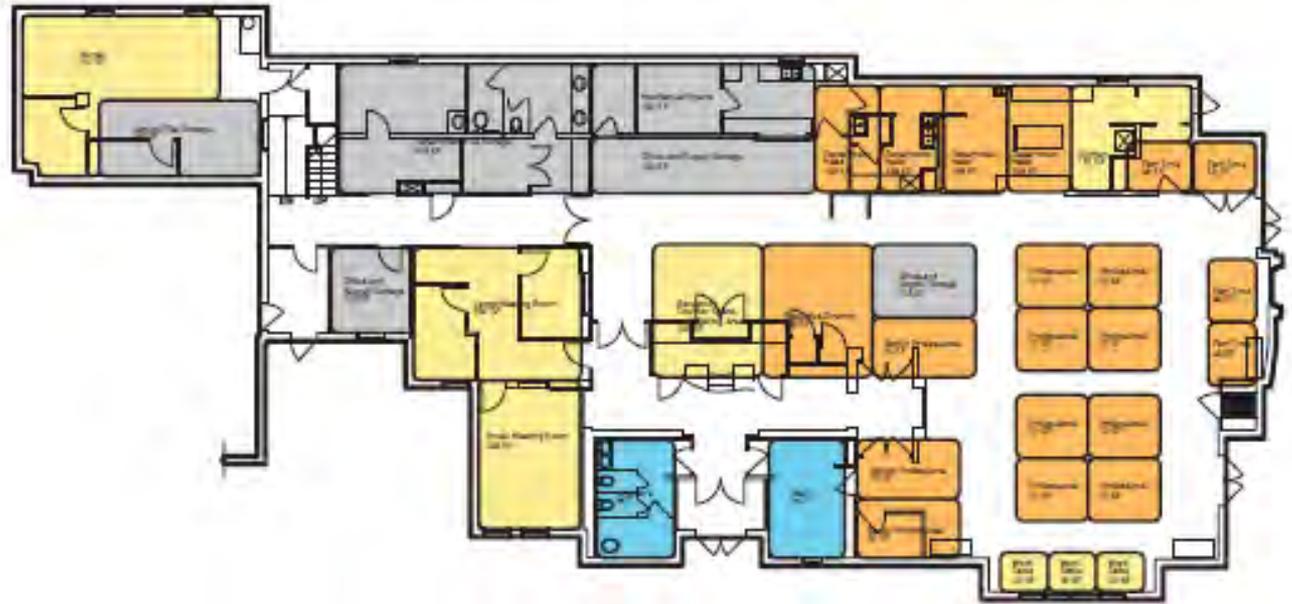
- Current Senior Center Floor Plan with Community Development Offices

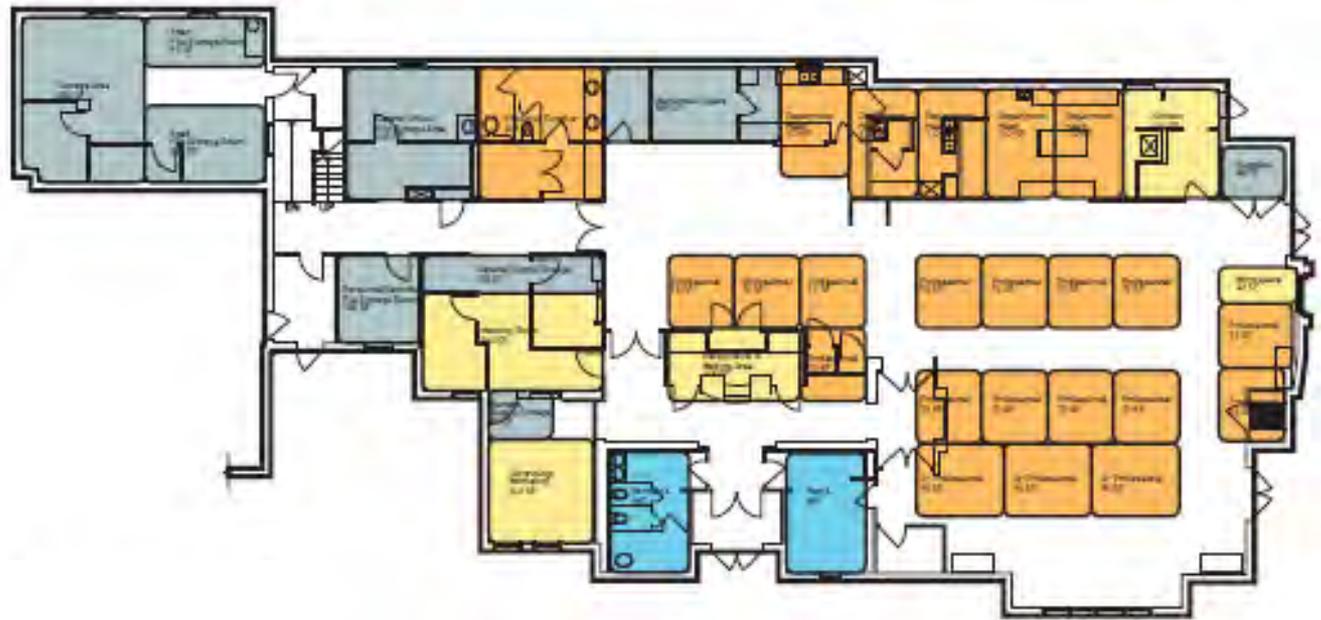
- Current Senior Center Floor Plan with School Department Administration Offices

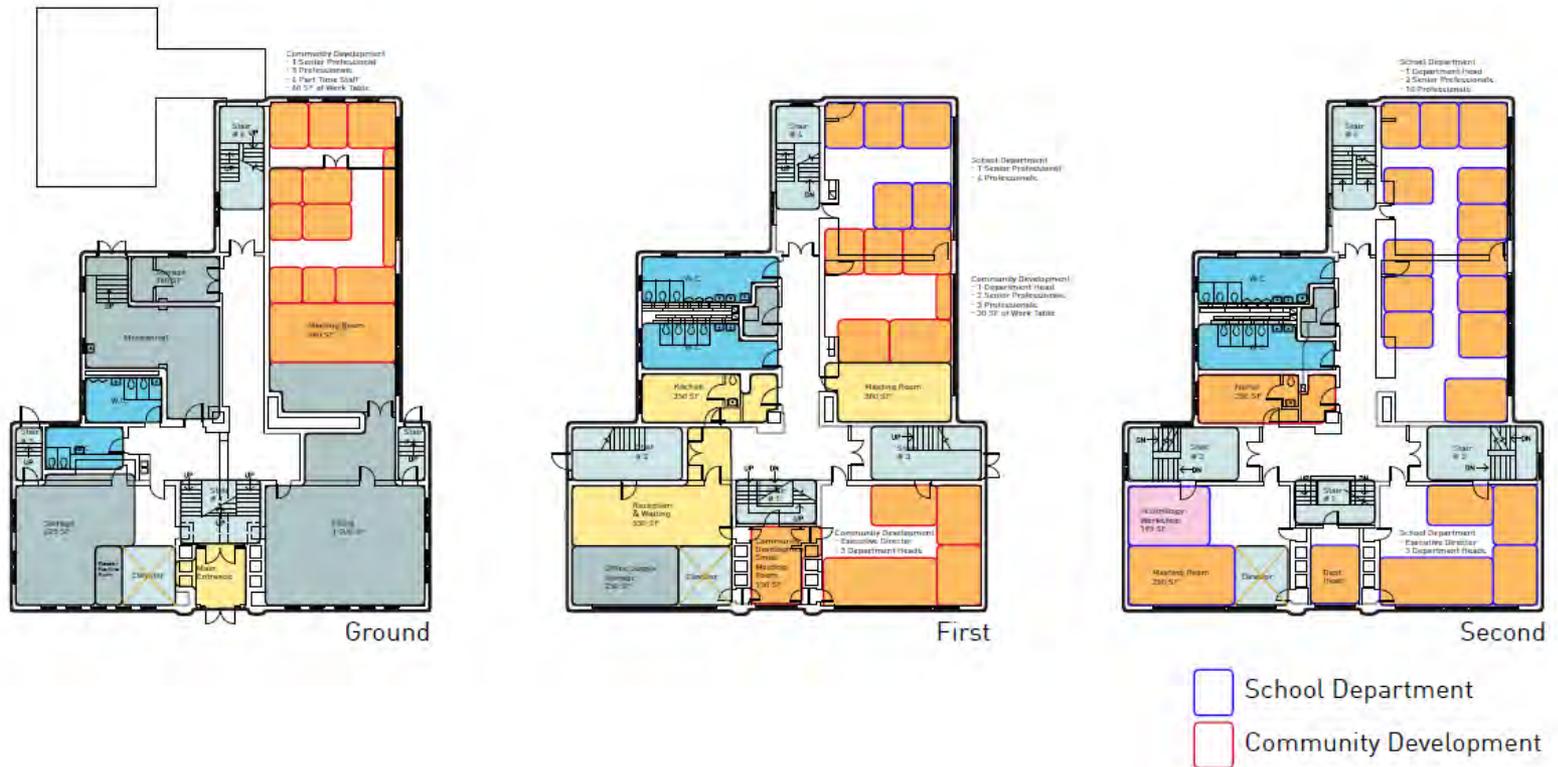
- The Bradstreet School with Community Development and School Department Offices

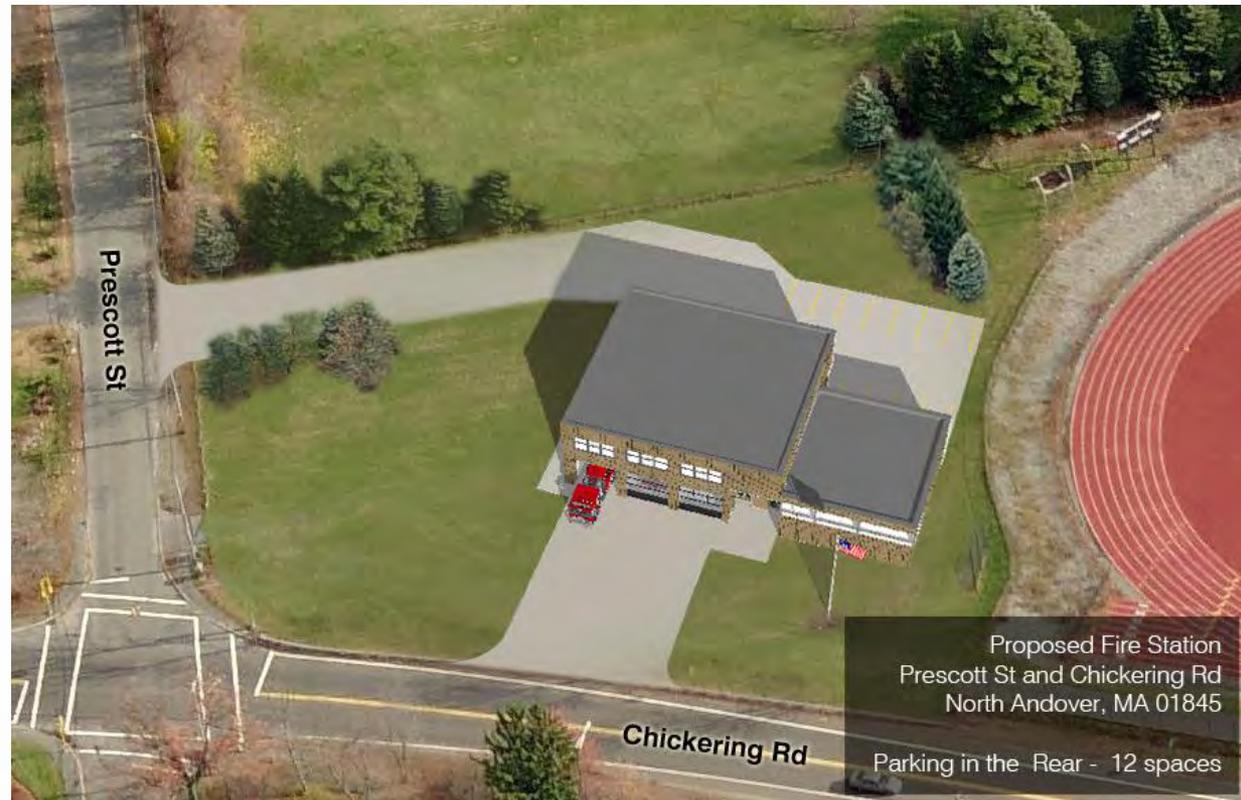
- New Fire Department Headquarters at Prescott Street/Route 125 Parcel study

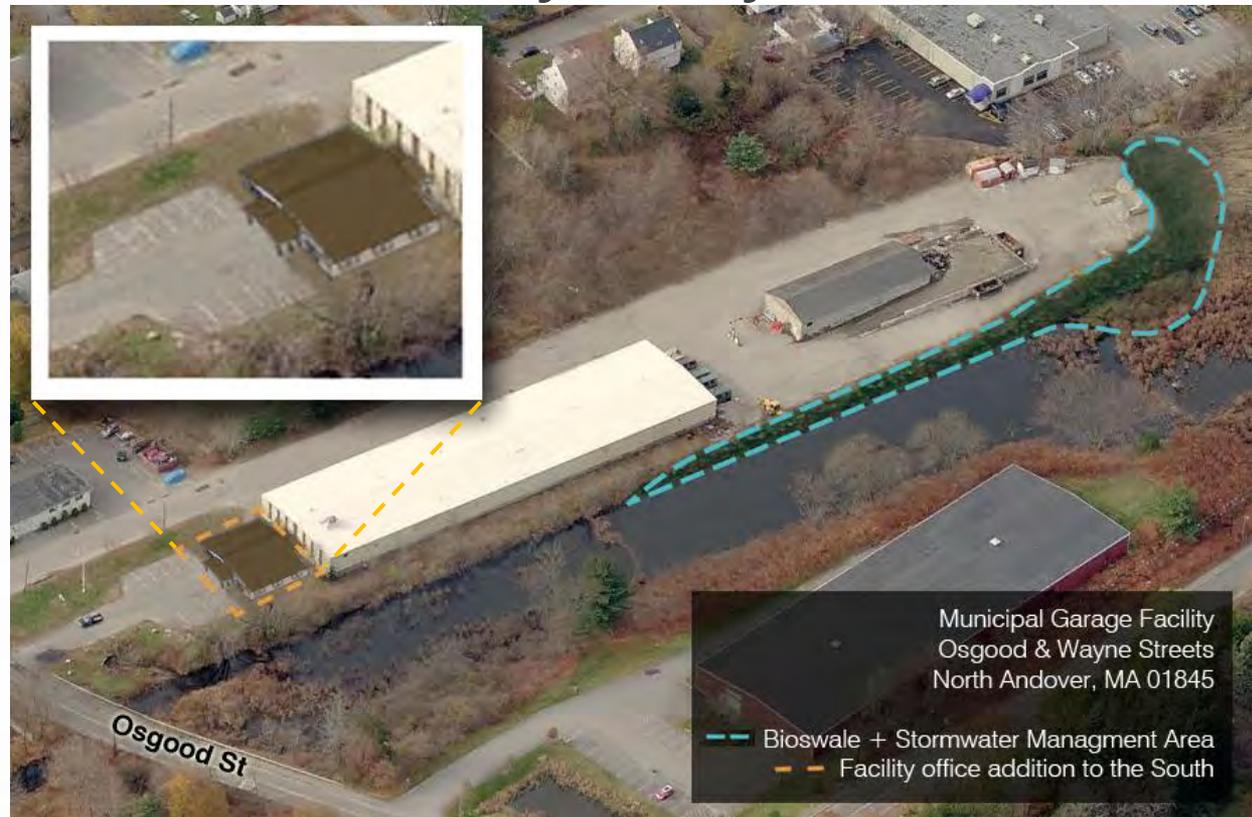
- Expansion of the existing Public Works facility at the Public Works facility study

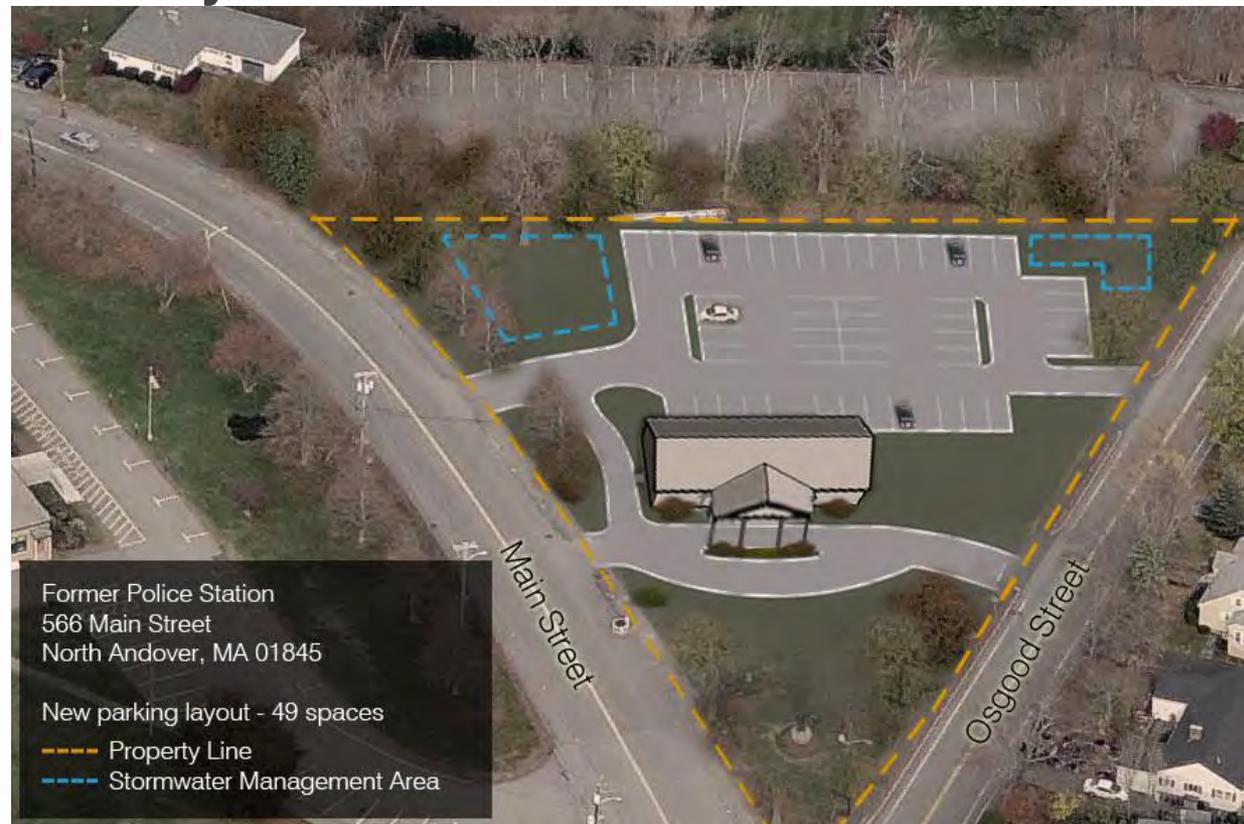
- Former Police Station building and property renovation study

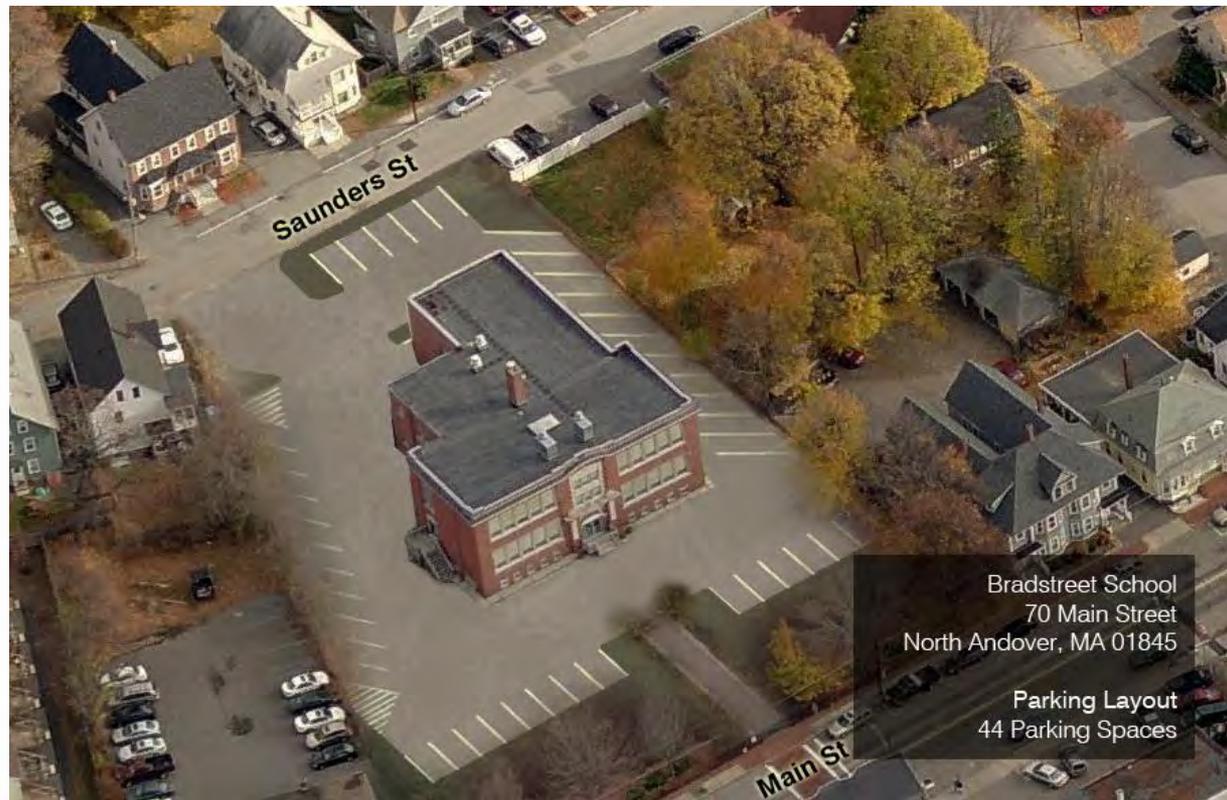
- The Bradstreet School site layout study
