# Town-wide Playground Assessments

Town of North Andover, Massachusetts

February 12, 2015

**Christine Scypinski, LEED AP  
Registered Landscape Architect**

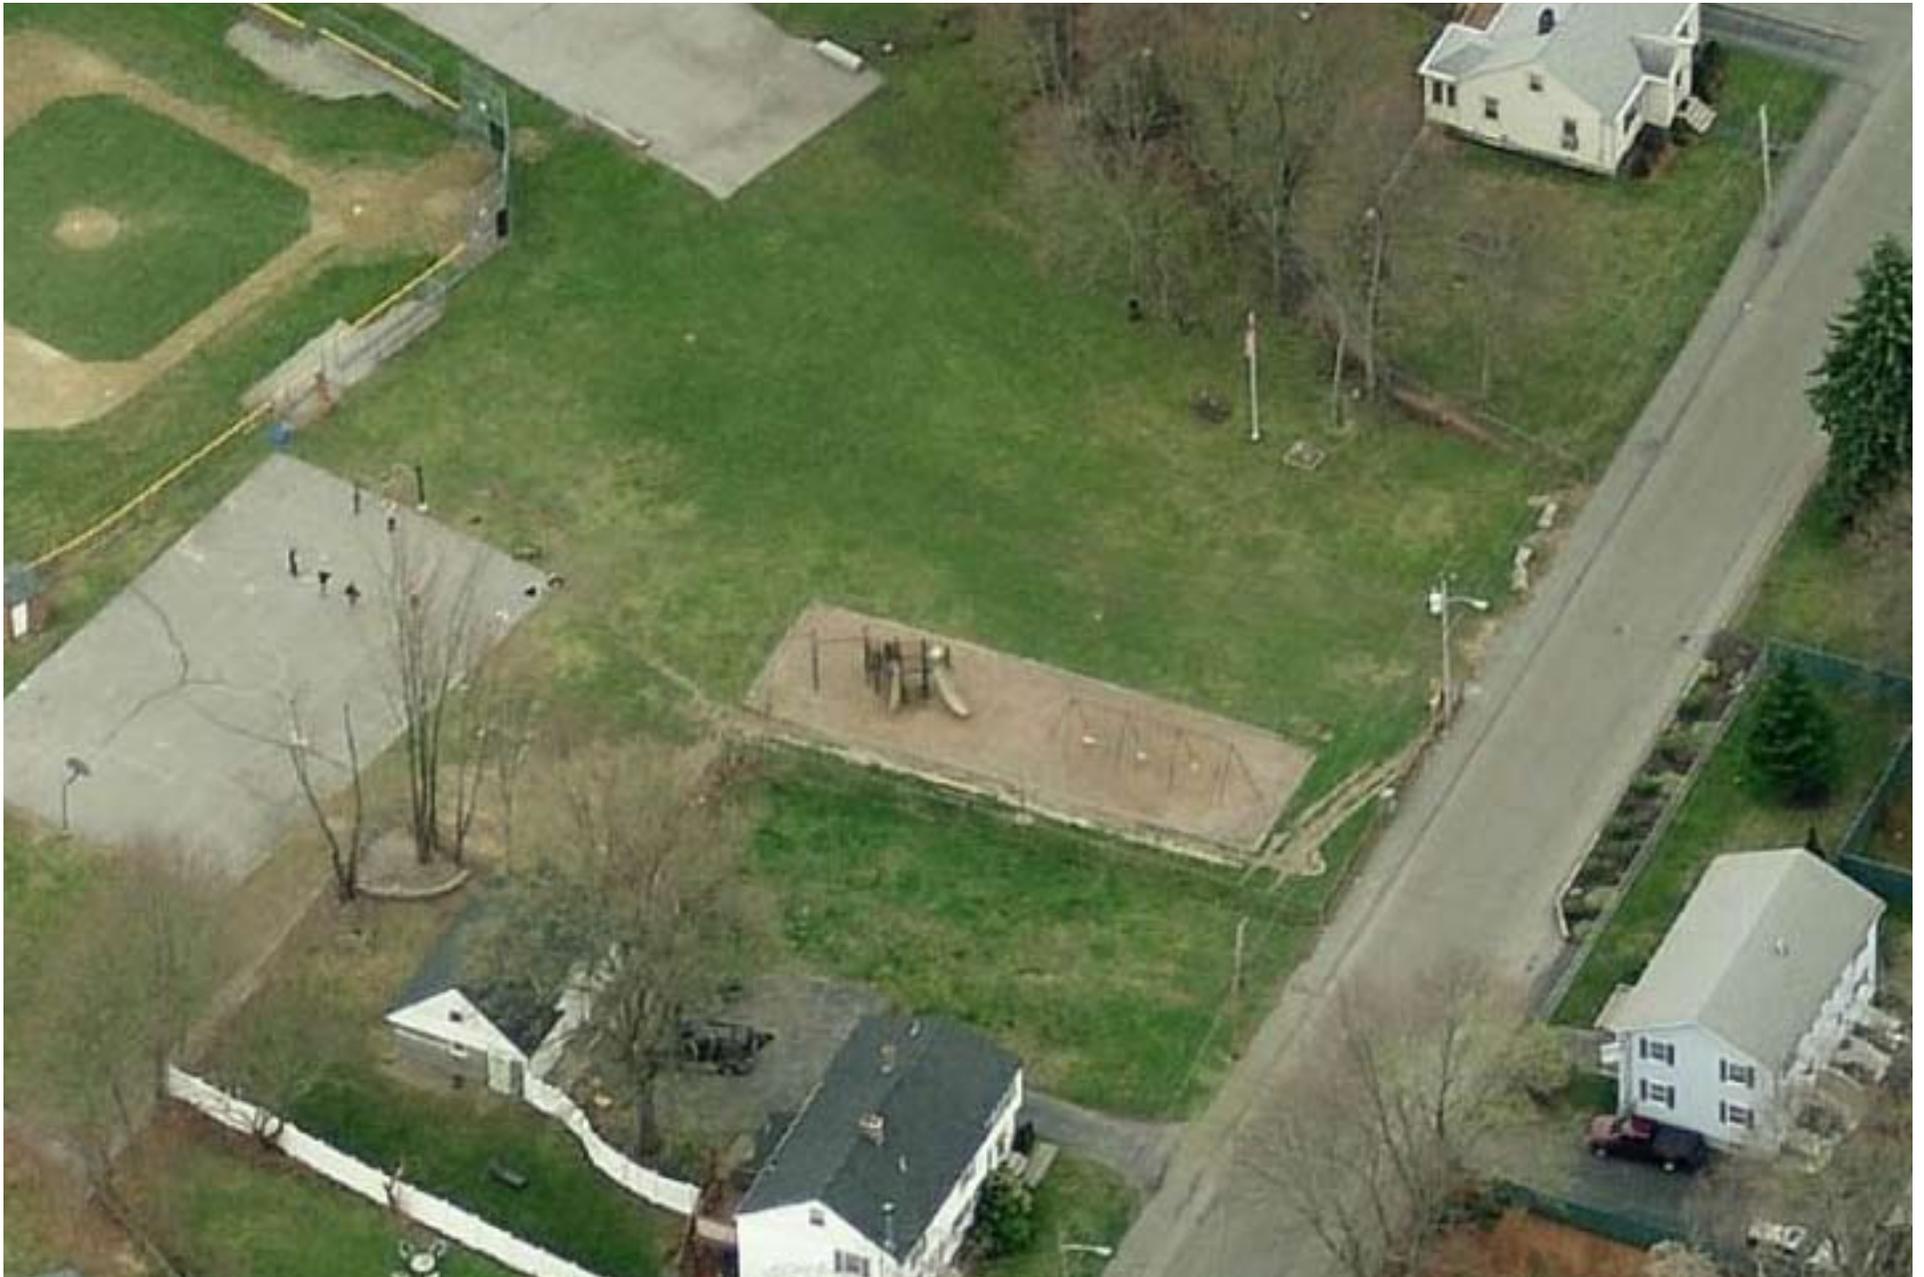
# Aplin Playground

Item	Ranking	Comments
Play Equipment Safety	1	good
Play Equipment Condition	3	fair - minor maintenance issues; extensive rust and peeling paint on swing posts; bent swing post
Play Equipment Universal Accessibility	1	good
Play Diversity and Separation for age groups and activities	3	fair for young children; separation of swings
Access to Playgrounds (accessible route)	5	no accessible path - flat grass to wood tie edge
Play Surface Accessibility	5	appears to be wood chips which is not acceptable; additional non-compliance evident in displaced wood chip areas at swings
Play Surface Condition & Safety (extent, depth, drainage)	5	wood chip surface is not as safe as wood fiber - 12"+ depth in general; deficient depth and deep ruts at swings and slides; deficient use zone around swings (need 2x ht)
Surfacing Edge Condition & Safety	1	new wood edge in good condition- could be CCA treated
General Playground Maintenance, Safety & Comfort	3	no trash or graffiti although maintenance issues noted for surface, no sun protection on south sides, no age appropriate signage, bench with small shade tree

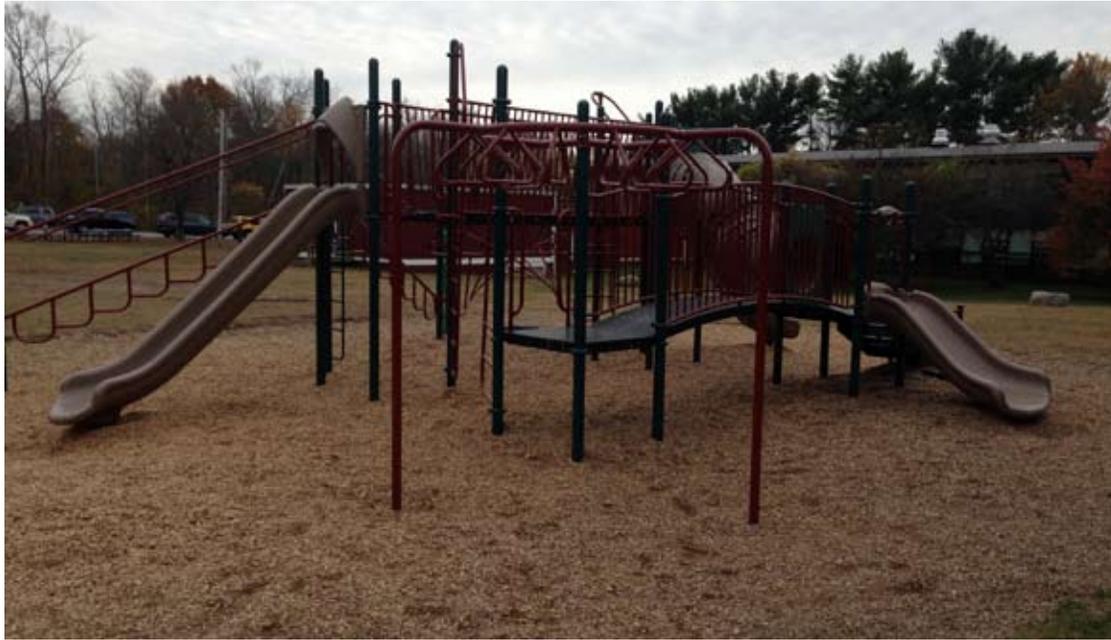
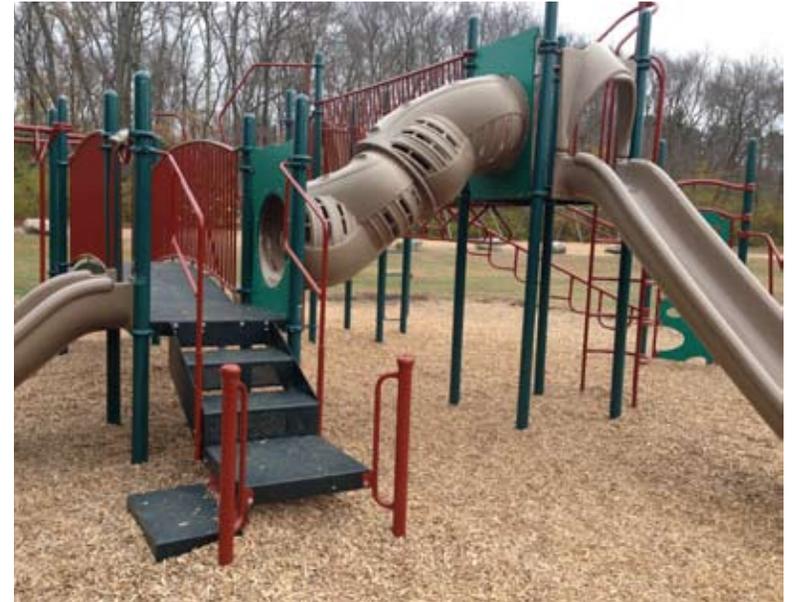
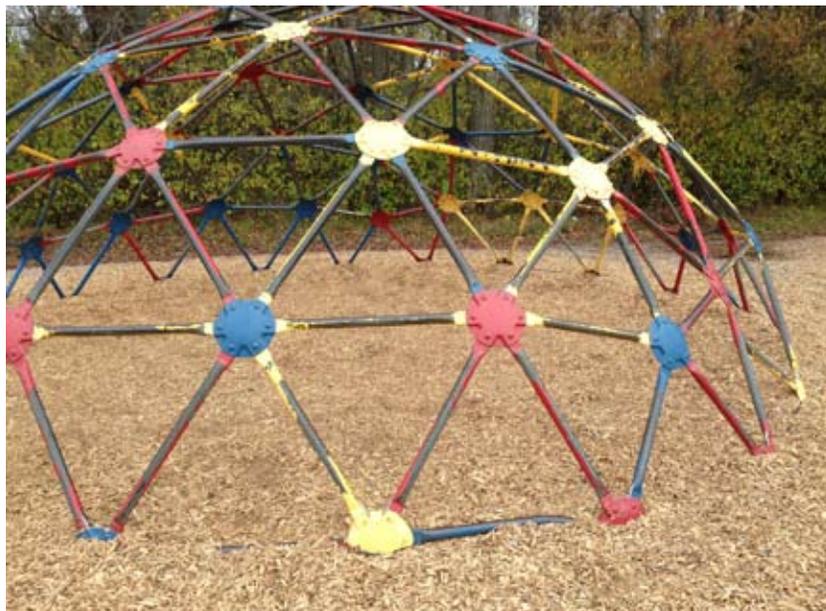
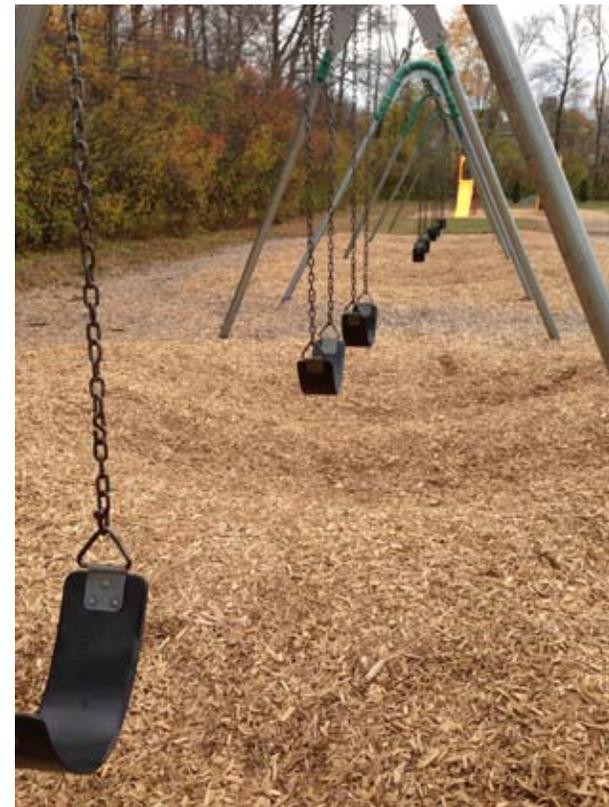
# Atkinson Elementary School

Item	Ranking	Comments
Play Equipment Safety	2	minor maintenance issues; considerable bare metal on dome and swing chains in full sun; potential bolt projection hazard on slide platform
Play Equipment Condition	2	new age 5-12 and 2-5 climbers - excellent; 6 bays of belt swings, climbing dome, stand-alone slides (2), climber & tunnel are older but strong - needs paint, missing bolts, bent rungs
Play Equipment Universal Accessibility	1	good for newer equipment
Play Diversity and Separation for age groups and activities	2	challenging; great play value; separation by age but lacks buffer areas
Access to Playgrounds (accessible route)	4	no accessible path to new 5-12 climber; poor mulch/dirt path to other pieces from parking lot - flat
Play Surface Accessibility	4	appears to be engineered wood fiber surface which can be accessible when maintained correctly (raked, filled, compacted in layers); non-compliance evident in displaced fiber areas; compaction of fiber topping needed; wood chips can not be substituted

Play Surface Condition & Safety (extent, depth, drainage)	4	wood fiber surface 12"+ depth in general; deficient depth under dome climber (7" to sand) and deep ruts at swings and slides; deficient use zone around swings (need 2x ht) and slides > 6' ht
Surfacing Edge Condition & Safety	5	no edge; wood fiber surface migrating
General Playground Maintenance, Safety & Comfort	4	no trash or graffiti although maintenance issues noted for equipment and surface, no barrier between parking and age 2-5 equipment but some distance, no sun protection on south sides, missing age appropriate signage, no benches or shade

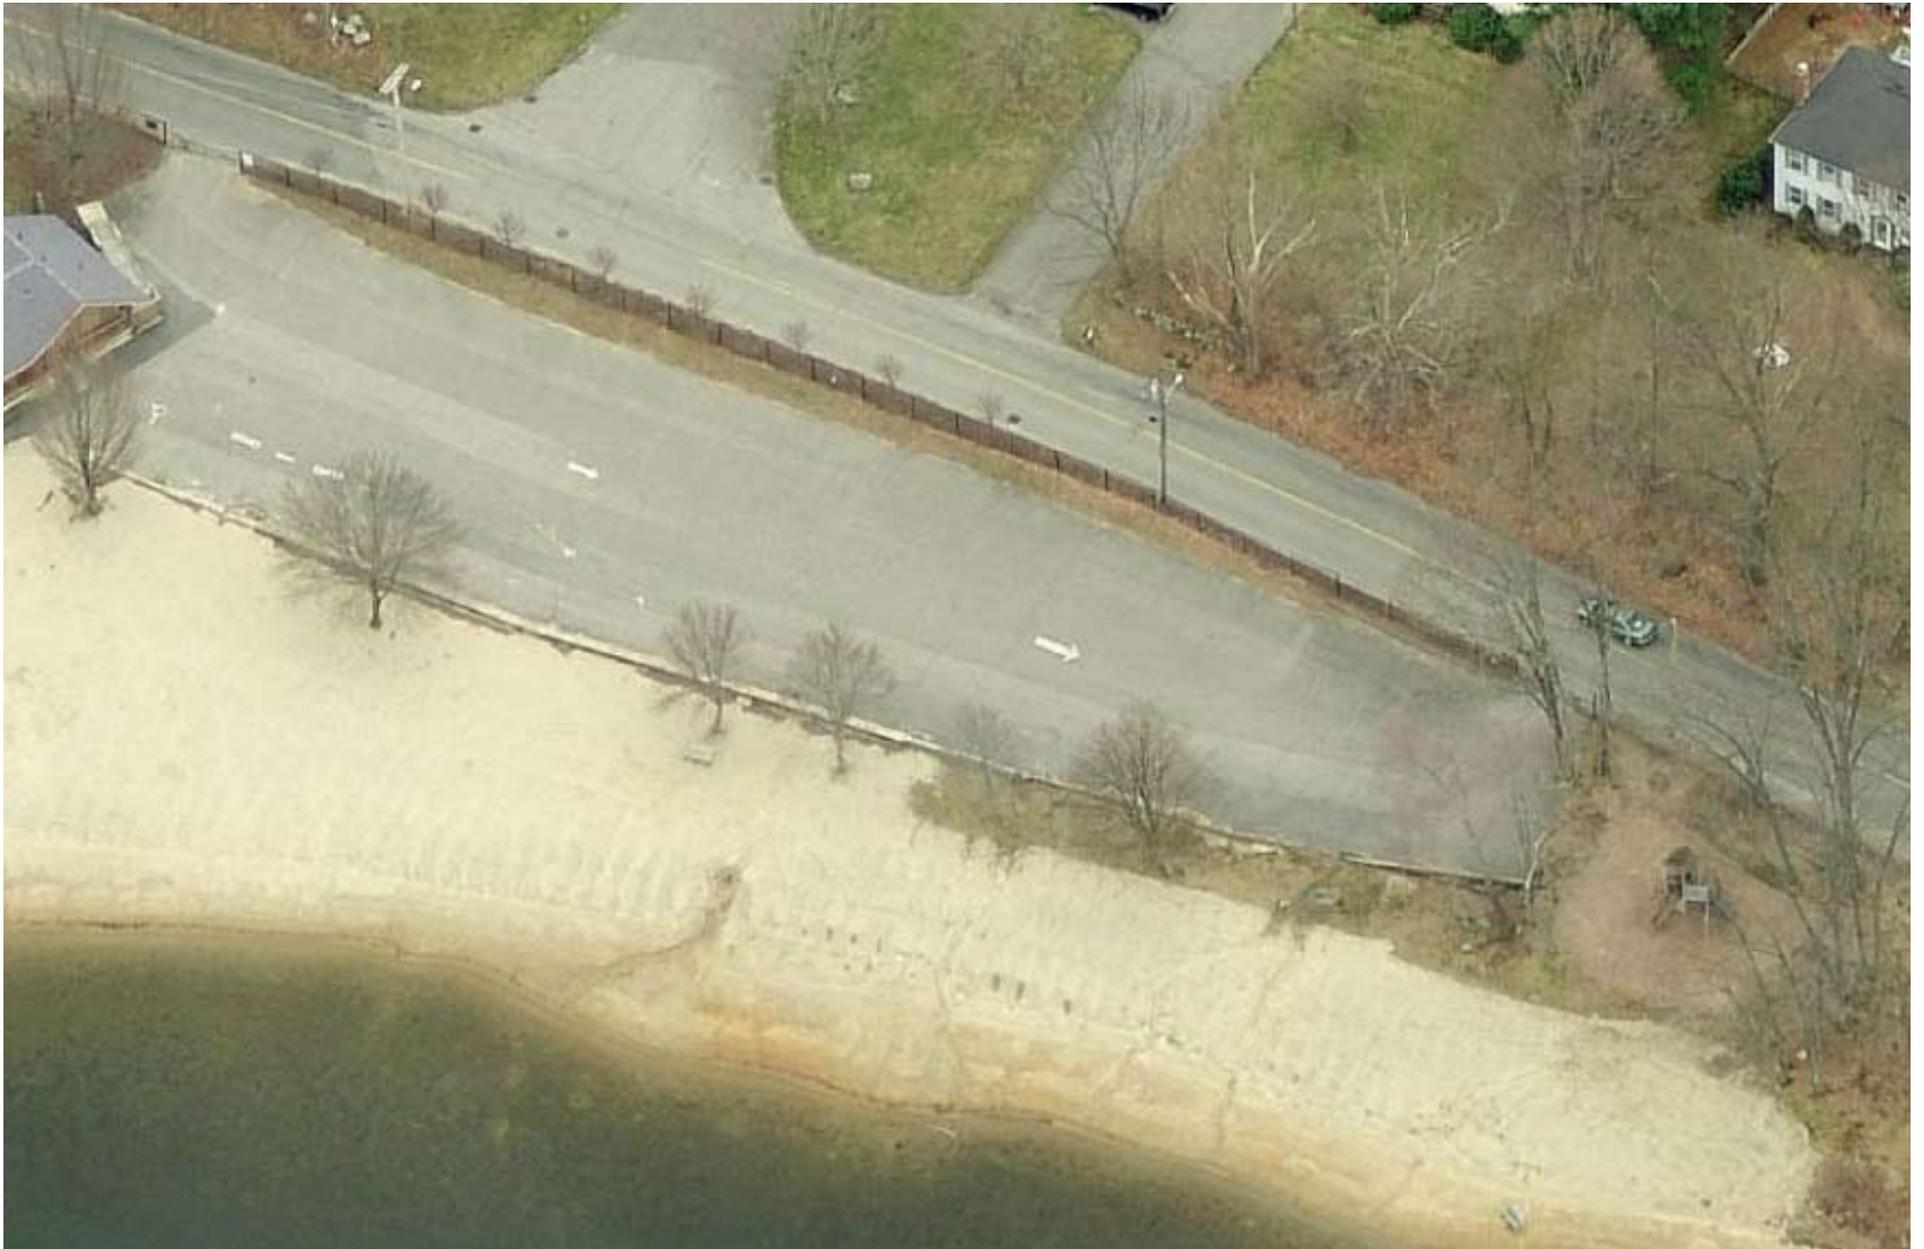
# Stevens Pond Beach Playground

Item	Ranking	Comments
Play Equipment Safety	1	good
Play Equipment Condition	1	good - some mildew at Plexiglas panels
Play Equipment Universal Accessibility	1	good
Play Diversity and Separation for age groups and activities	4	fair to poor - small climber for age 5-12; ground level activities; no swings
Access to Playgrounds (accessible route)	5	wood chip surface from parking is not accessible due to material and slope
Play Surface Accessibility	5	appears to be wood chips which is not acceptable; additional non-compliance evident in displaced wood chip area at slide
Play Surface Condition & Safety (extent, depth, drainage)	5	wood chip surface is not as safe as wood fiber - 6" and less depth in general; deficient depth and deep ruts at slide; deficient use zone at slide - also sloped; grass growing
Surfacing Edge Condition & Safety	5	no edge - wood chips migrating
General Playground Maintenance, Safety & Comfort	2	no trash or graffiti although maintenance issues noted for surfacing; separation from road with fence but close to parking without barrier; very short use zone at slide exit and steep slope; shade from trees and canopies; 5-12 age signage; no benches

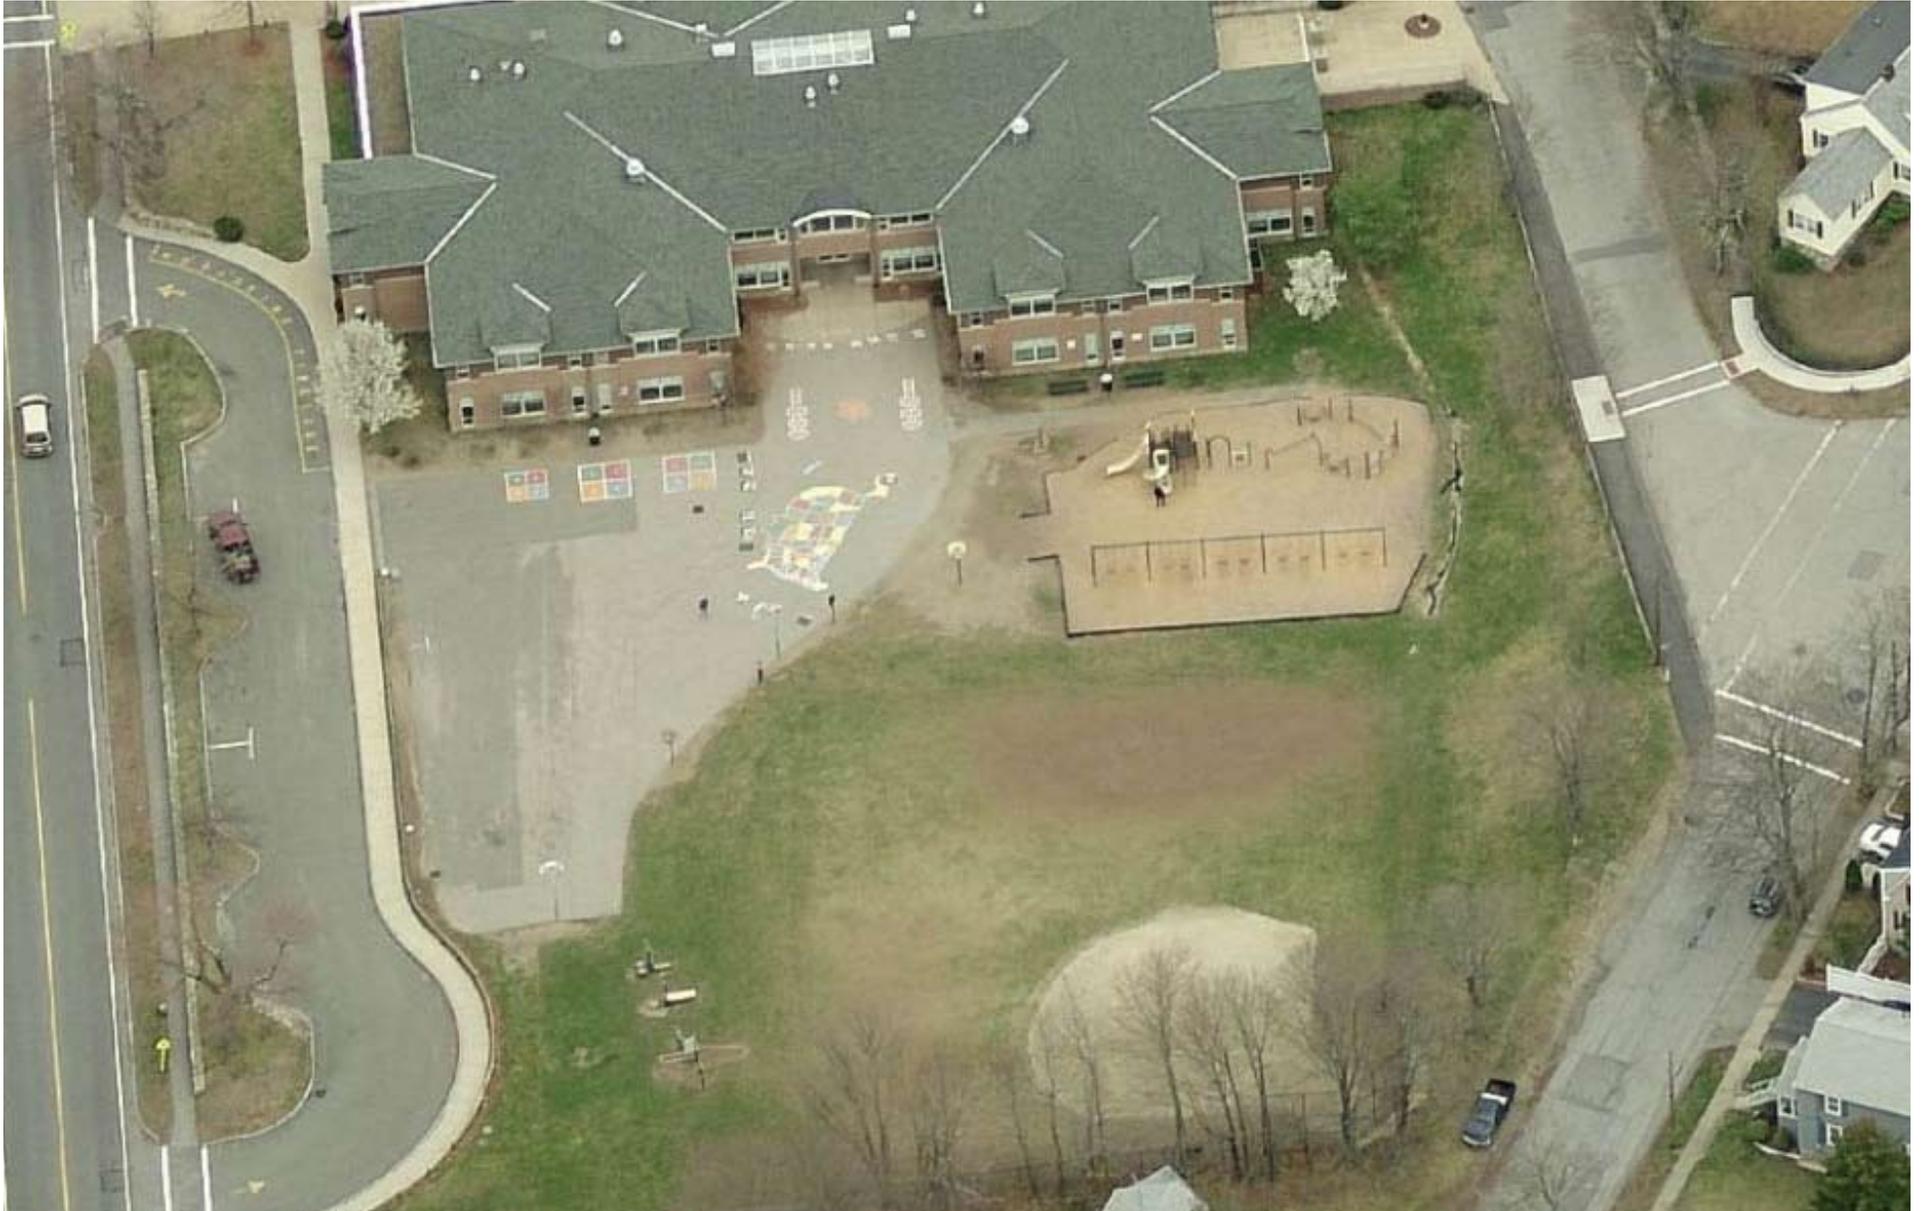
# Thomson Elementary School

Item	Ranking	Comments
Play Equipment Safety	2	minor maintenance issues; bare metal on balance beams in full sun; rubber steps on pieces worn to metal; belt swing missing; some rust starting and coating on steps peeling
Play Equipment Condition	2	good - minor maintenance issues
Play Equipment Universal Accessibility	1	good
Play Diversity and Separation for age groups and activities	1	challenging; good play value; separation of swings
Access to Playgrounds (accessible route)	2	accessible path from school but in poor shape with spill over of mulch on bituminous walk
Play Surface Accessibility	4	appears to be engineered wood fiber surface which can be accessible when maintained correctly (raked, filled, compacted in layers); non-compliance evident in displaced fiber areas; compaction of fiber topping needed; wood chips can not be substituted
Play Surface Condition & Safety (extent, depth, drainage)	4	wood fiber surface 12"+ depth in general; deficient depth and deep ruts at swings and slides; poor drainage in areas with ground water just below the surface; grass in areas

Surfacing Edge Condition & Safety	4	plastic edge with damaged and missing sections; protruding bolts causing hazards
General Playground Maintenance, Safety & Comfort	2	no trash or graffiti although maintenance issues noted for surface, no sun protection on south sides or equipment, age 5-12 signage, benches but in poor shape and without shade
